APEX TEMPLATE FOR HOME INSPECTIONS

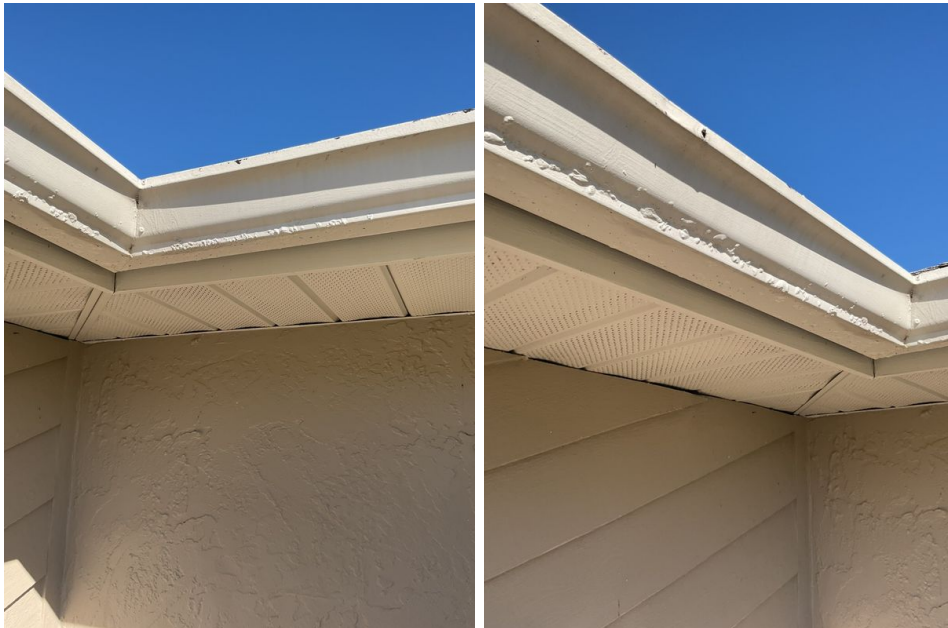
GUTTER DAMAGED

I observed damage to the gutter. This is a defect that should be corrected by a professional contractor.

Contact a qualified gutter contractor

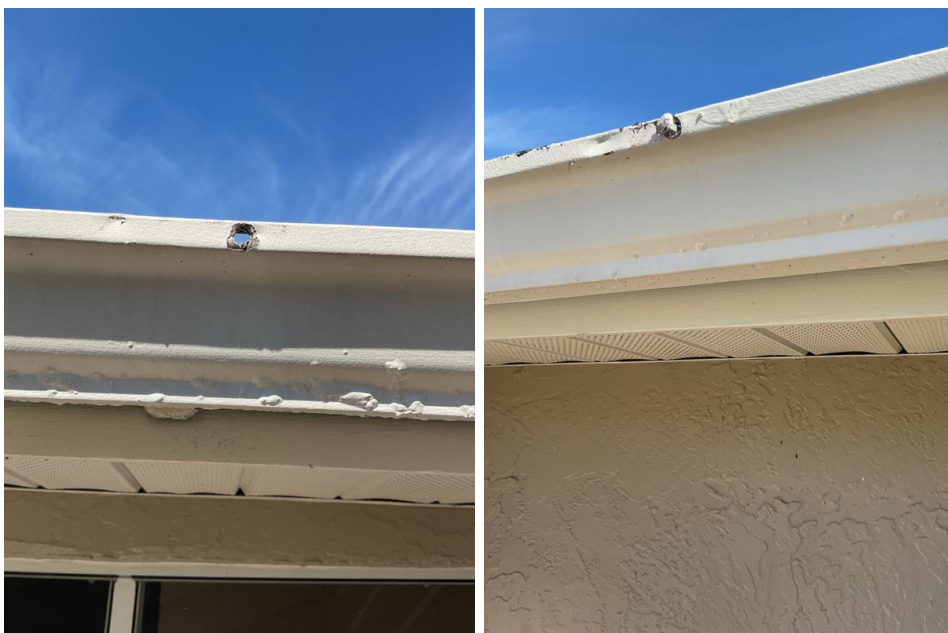
2.6.2 Gutters & Downspouts

GUTTER FASTENING DEFECT

I observed indications of a defect at the gutter fastening at numerous locations around the house

Contact a qualified gutter contractor

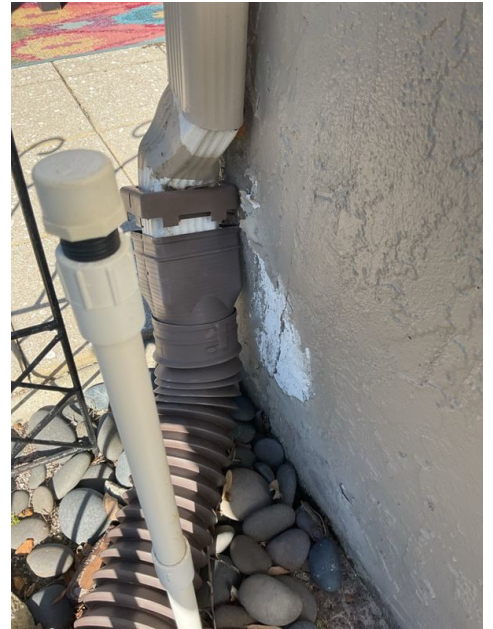
2.6.3 Gutters & Downspouts

DOWNSPOUT DETACHED

I observed indications of a disconnected and detached downspout pipe. Easy fix.

Contact a qualified roofing professional.

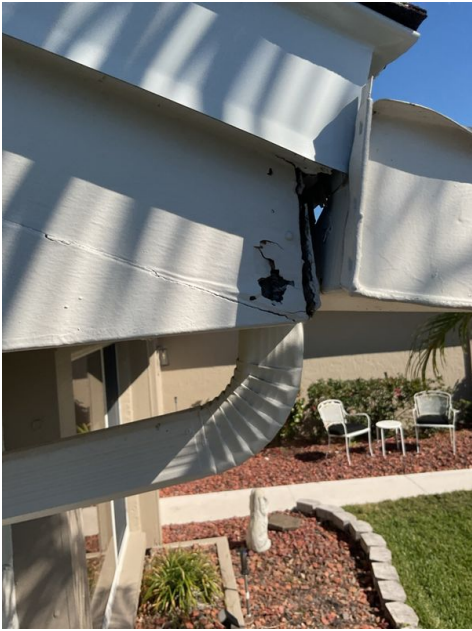
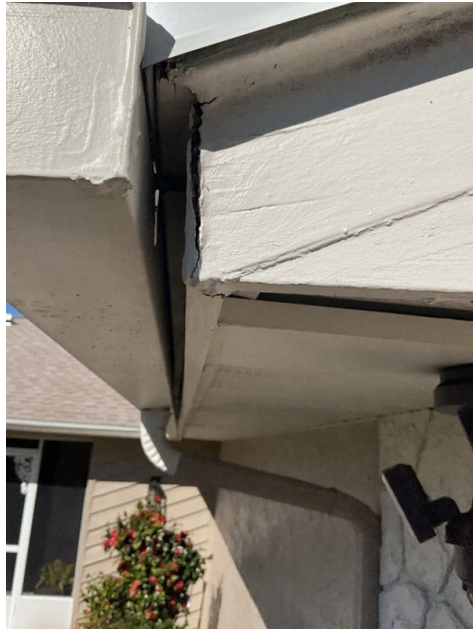
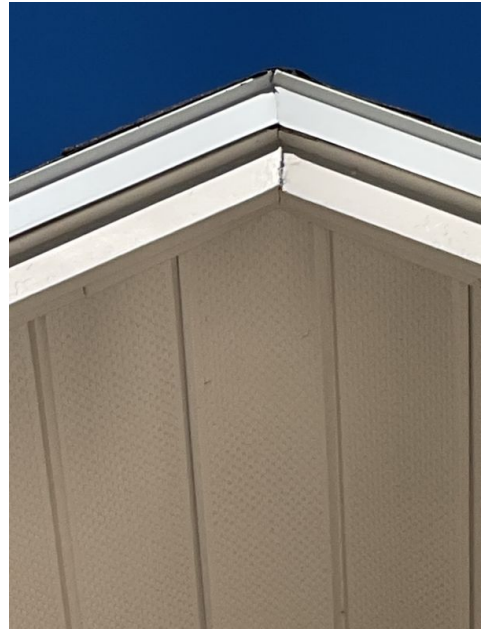
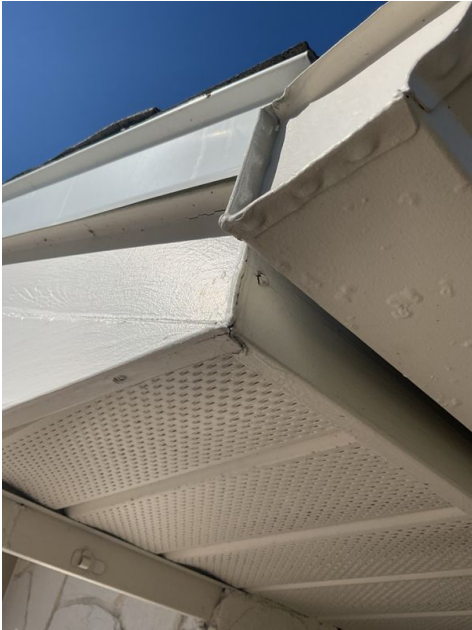
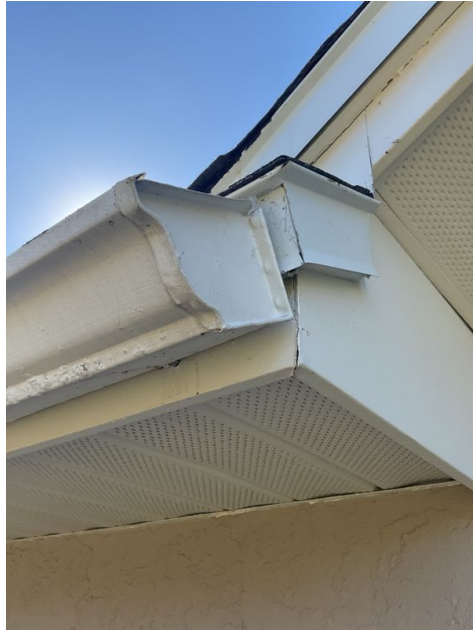
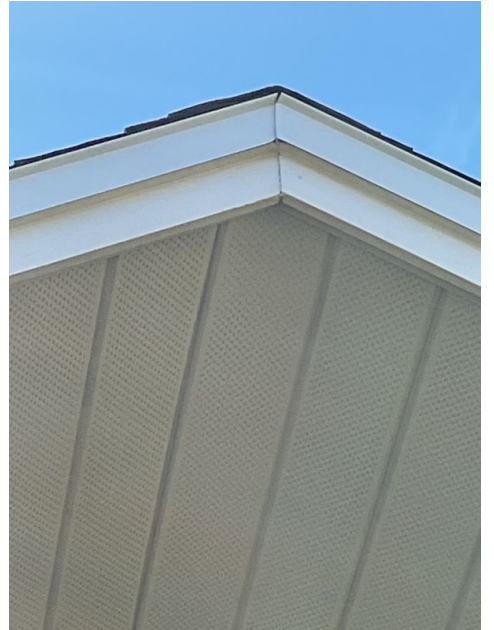
DAMAGE OBSERVED AT FASCIA

I observed indications that one or more areas of the fascia were damaged.

Correction and further evaluation is recommended.

Contact a qualified general contractor.

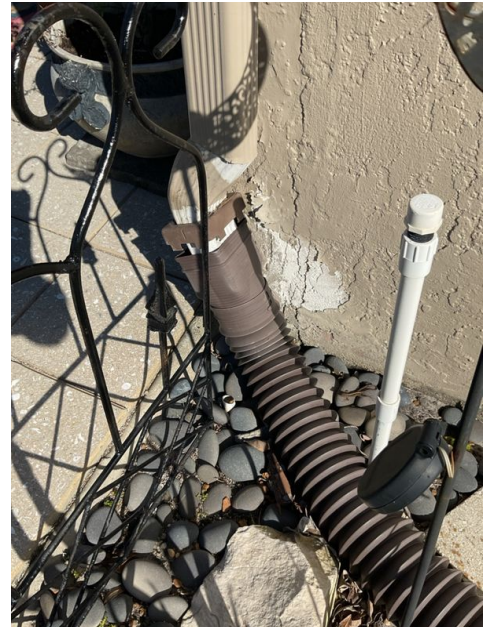
3.3.1 Wall-Covering, Flashing & Trim

DAMAGED WALL-COVERING MATERIAL

I observed indications of a defect at the exterior wall-covering material.

Correction and further evaluation is recommended.

Contact a qualified professional.

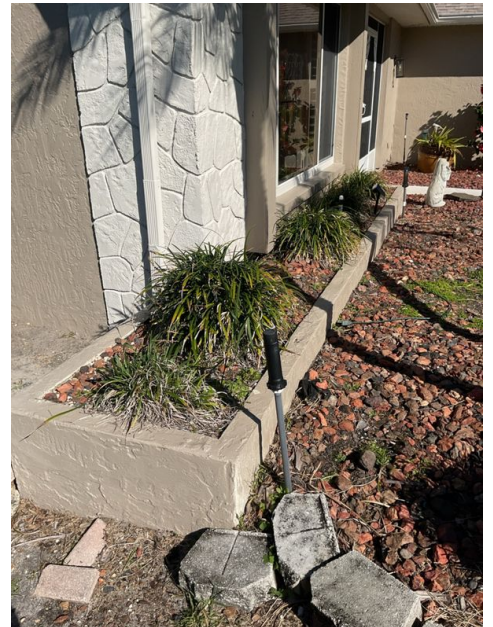
3.4.1 Vegetation, Surface Drainage, Retaining Walls & Grading

RETAINING WALL DAMAGE

I observed a raised planter box along the front of the home. This could lead to water intrusion along this wall if this area gets too much water. Recommend monitoring

Contact a qualified landscaping contractor

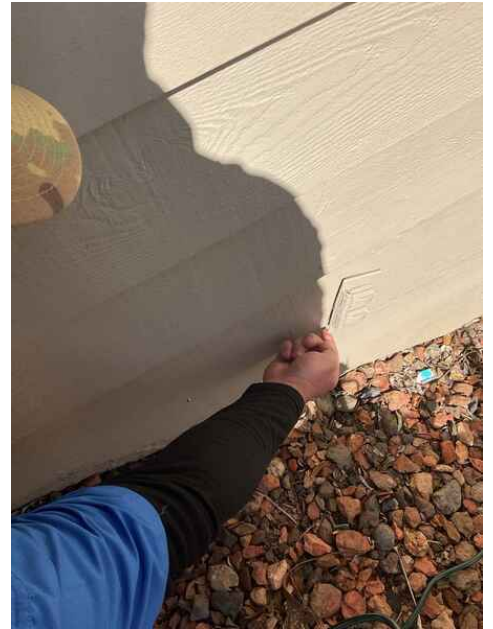
ELECTRICAL DEFECT

I observed indications of an electrical defect at the exterior. The outlet to the right of the patio is inoperative and loose. Recommend an electrical contractor replace and update with gfci and determine why it does not have power.

Contact a qualified electrical contractor.

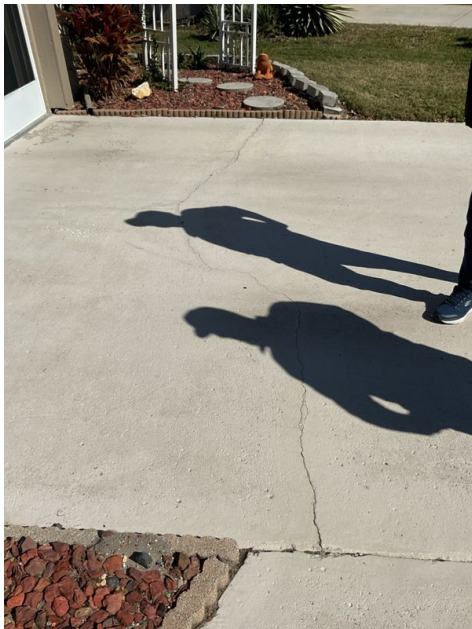
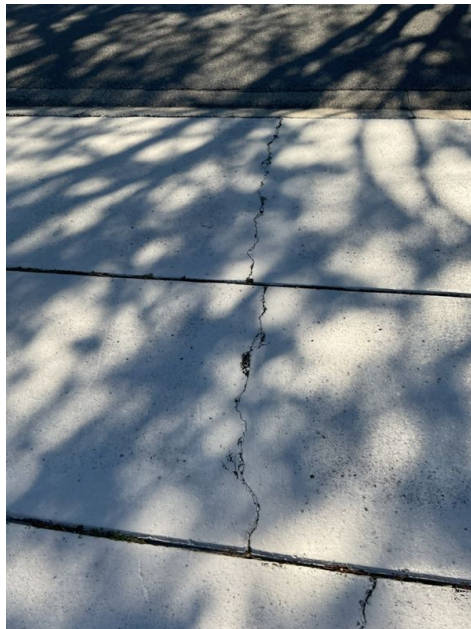
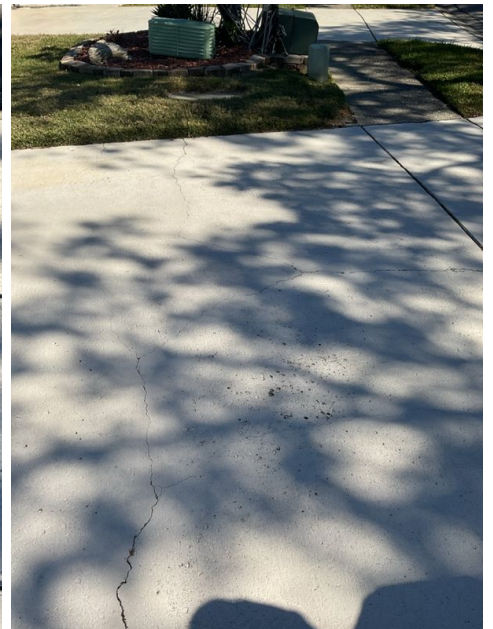
3.6.1 Walkways & Driveways

MAJOR CRACKING AT DRIVEWAY

I observed indications of major cracking at the driveway.

Correction and further evaluation is recommended.

Contact a qualified concrete contractor.

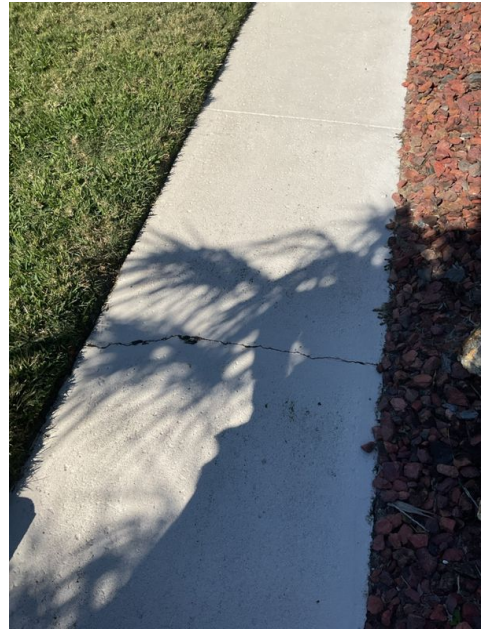
3.6.2 Walkways & Driveways

MINOR CRACKING AT WALKWAY

I observed minor cracking and no major damage at the walkway.

Monitoring is recommended.

Recommendation
Contact a handyman or DIY project

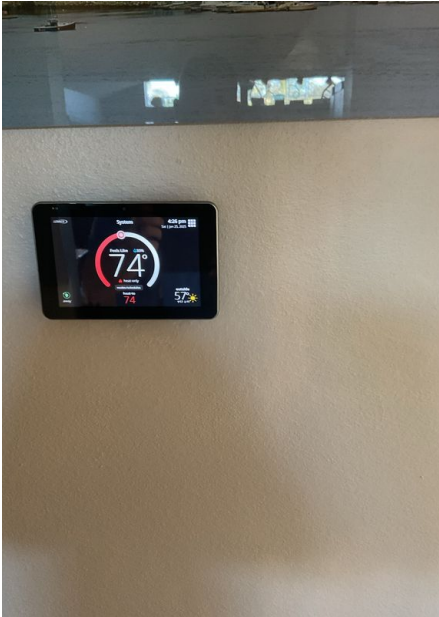
Thermostat and Normal Operating Controls: Thermostat Location

Hall way

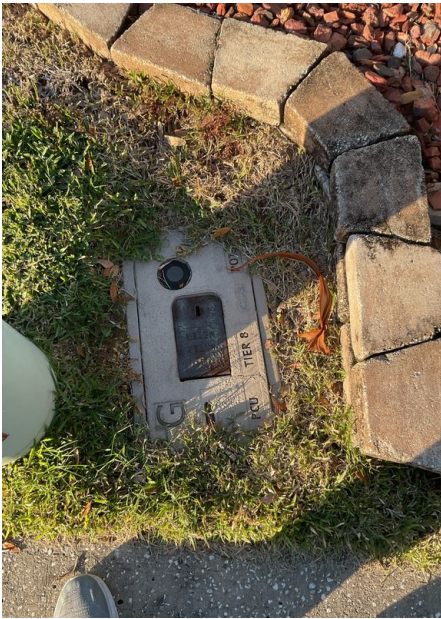
Main Water Shut-Off Valve: Location of Main Shut-Off Valve

Outside of House

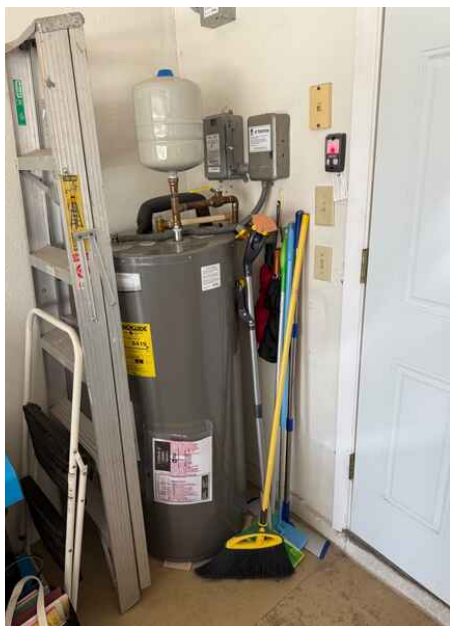
Hot Water Source: Inspected Hot Water Source

I inspected the hot water source and equipment according to the [Home Inspection Standards of Practice](#).

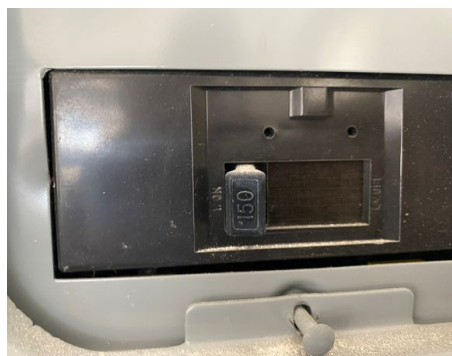
150

I observed indications of the main service disconnect's amperage rating. It was labeled.

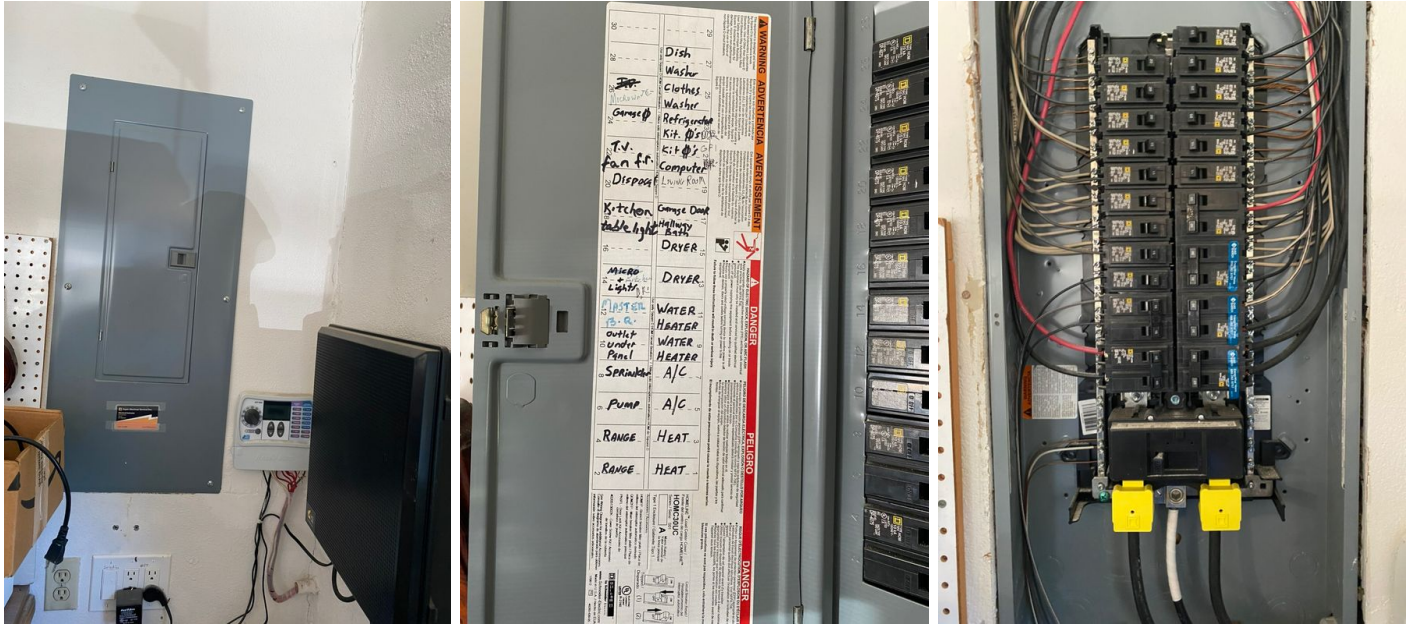
Panelboards & Breakers: Inspected Main Panelboard & Breakers

I inspected the electrical panelboards and over-current protection devices (circuit breakers and fuses).

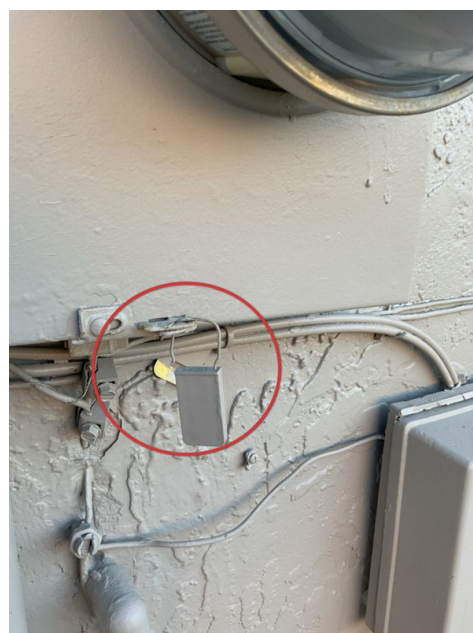
TAMPER RESISTANT LOCK BROKEN

Contact electronic company to replace

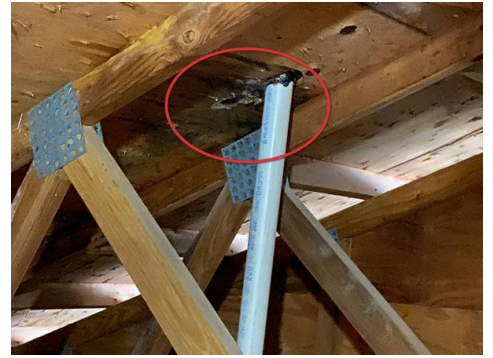
9.1.1 Structural Components & Observations in Attic
PRIOR WATER PENETRATION OBSERVED

I observed indications that sometime in the past there was water penetration or intrusion into the attic. Water marks were observed. This area did not show signs of active leaks and there was no moisture present. Correction and further evaluation is recommended.

Recommend monitoring.

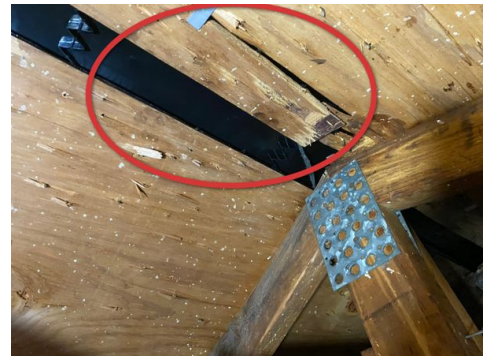
9.1.2 Structural Components & Observations in Attic

STRUCTURAL DEFECT IN ATTIC

I observed a major structural defect in the attic. Edge and corner of sheathing for roof at ridge vent damaged and broken.

Contact a qualified carpenter.

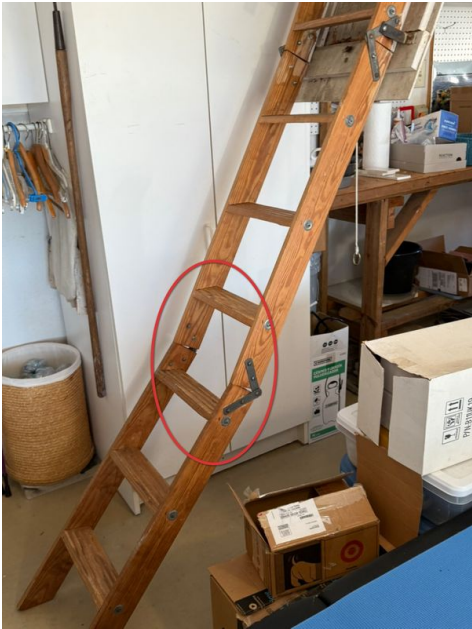
9.4.1 Attic Ladder

ATTIC LADDER UNSAFE

The attic ladder in the garage is not properly set to meet the floor at the right angle and is hazardous. Recommend replacing

Contact a qualified professional.

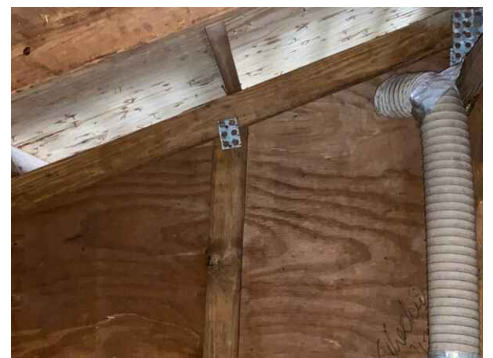
IMPROPERLY EXHAUSTING

I observed that the bathroom fan is improperly exhausting air from the bathroom.

Contact a qualified general contractor.

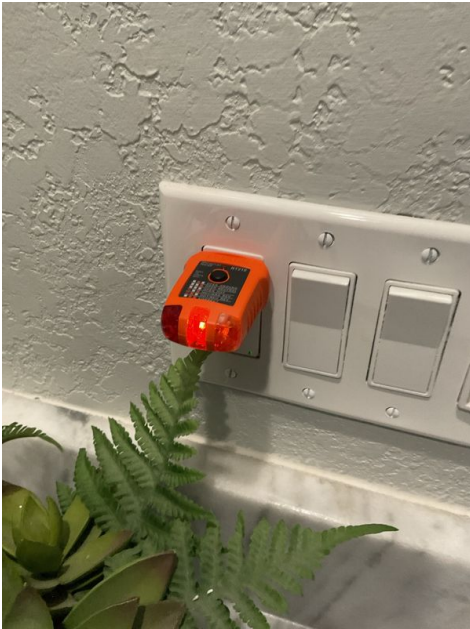
10.4.1 GFCI & Electric in Bathroom

GFCI IMPROPERLY WIRED

I observed a defect at the GFCI in the bathroom. tests as not having a ground and will not trip when tested.

Contact a qualified electrical contractor.

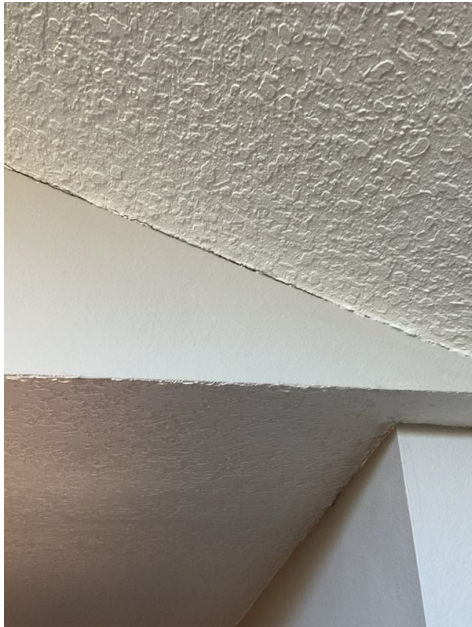
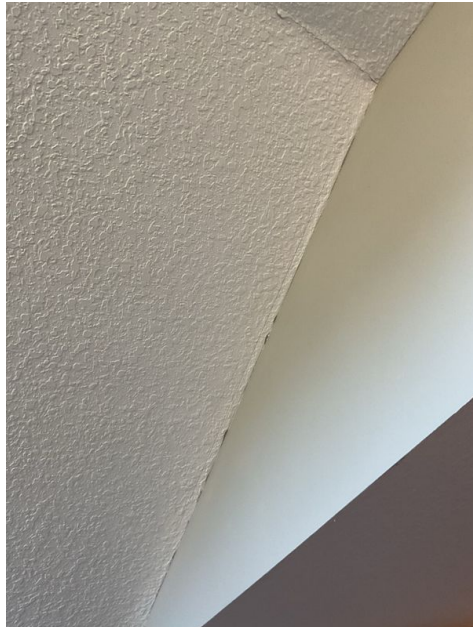
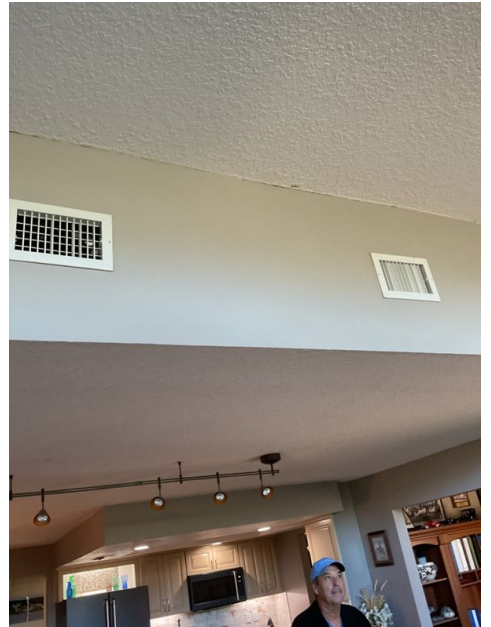
MAJOR CORNER CRACKS

I observed along the ceiling in the living room.

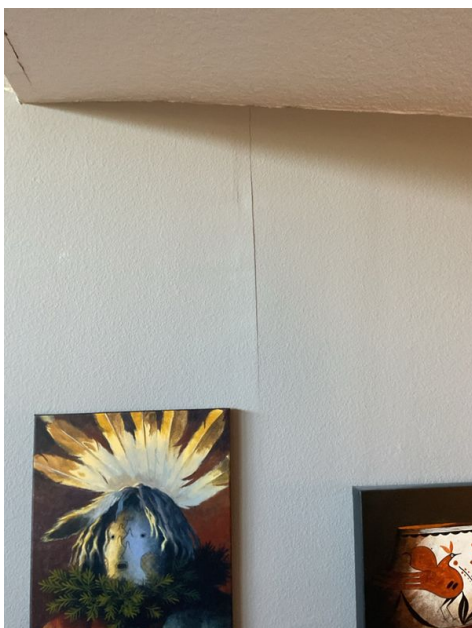
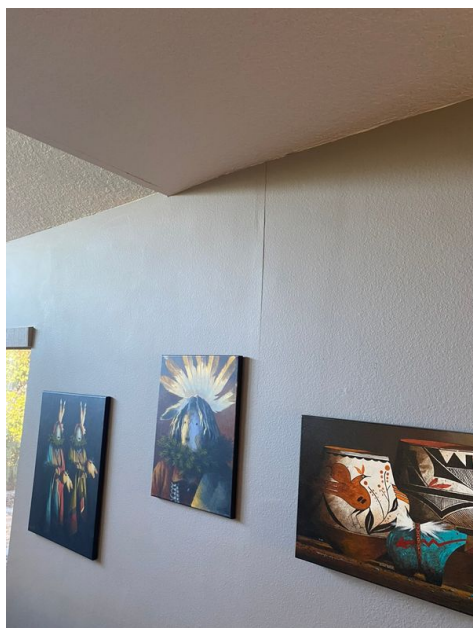
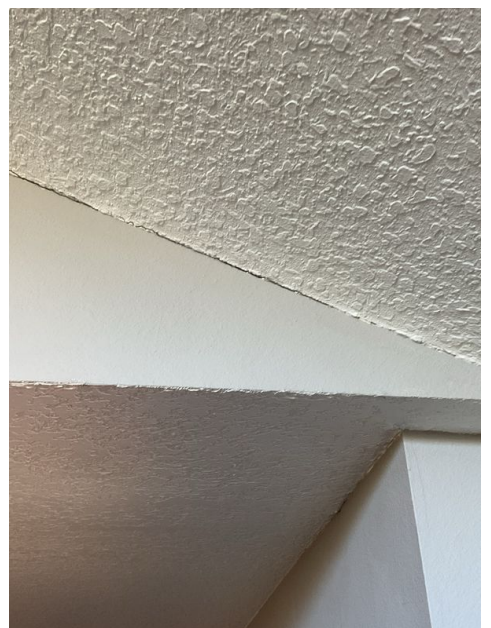
11.4.2 Floors, Walls, Ceilings

DRYWALL DAMAGE

There is misc drywall damage around the house.

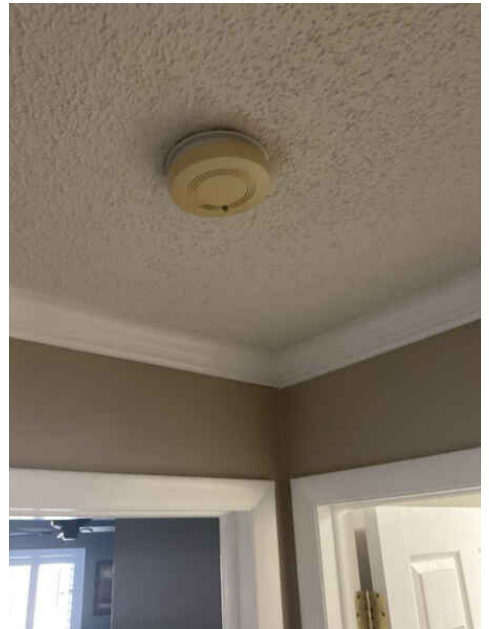
11.7.1 Presence of Smoke and CO Detectors

OLD DETECTORS, NEW DETECTORS RECOMMENDED

I observed indications of old smoke detectors in the house. Detectors should be replaced every 5-10 years. They should be hard-wired with electricity and have a battery backup feature in case the electricity turns off. New smoke detectors are recommended.

Contact a qualified professional.

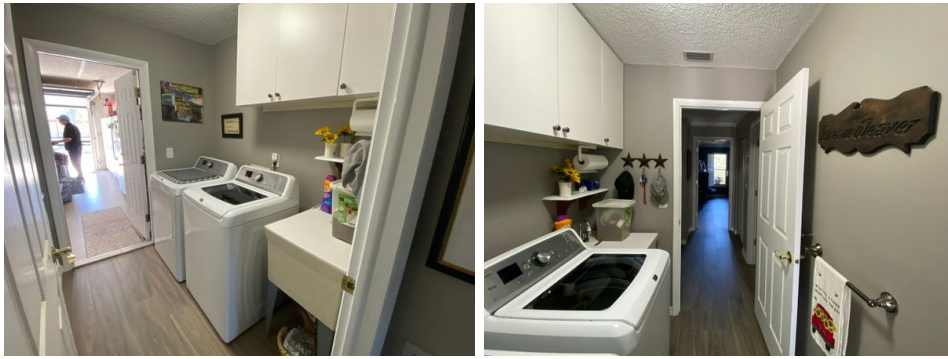
DID NOT INSPECT

I did not inspect the clothes washer and dryer fully. These appliances are beyond the scope of a home inspection. I did not operate the appliances. The clothes dryer exhaust pipe must be inspected and cleaned every year to help prevent house fires.

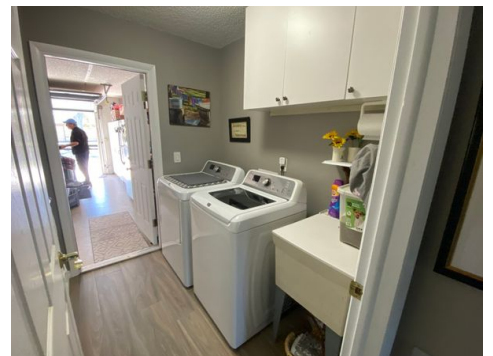
LAUNDRY TUB

I could not inspect the laundry tub as it has numerous items on top of it.

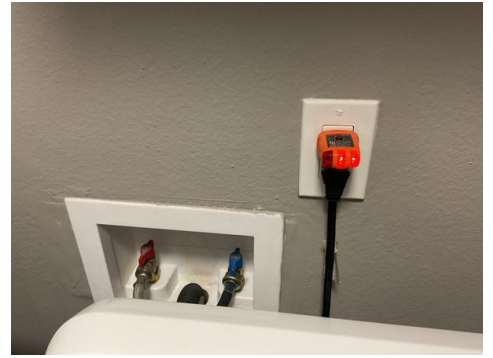
12.1.1 Clothes Washer

MISSING GFCI PROTECTION IN LAUNDRY

I observed missing GFCI protection for all receptacle outlets in the laundry, as it is required by standards.

Contact a qualified electrical contractor.

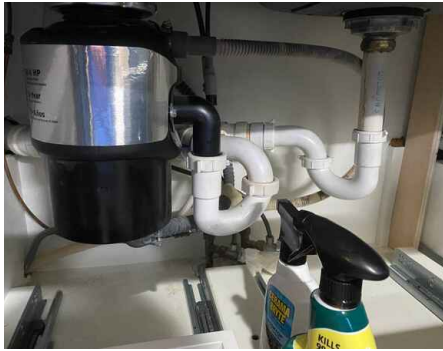
Garbage Disposal: Turned On Garbage Disposal

I turned on the garbage disposal.

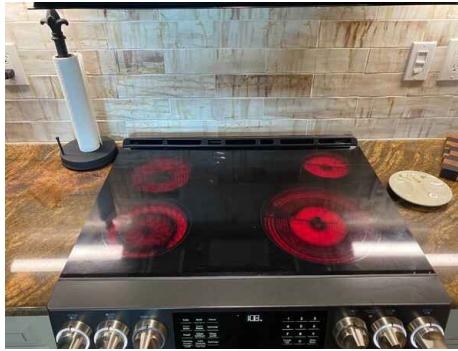
Range/Oven/Cooktop: Turned On Stove & Oven

I turned on the kitchen's stove and oven.

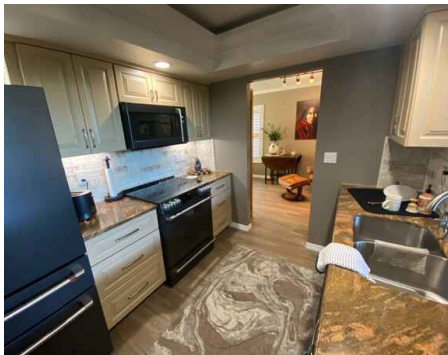
Refrigerator: Refrigerator Was On

I checked to see if the refrigerator was on. It was. That's all I inspected in relation to a refrigerator. Refrigerators are beyond the scope of a home inspection.

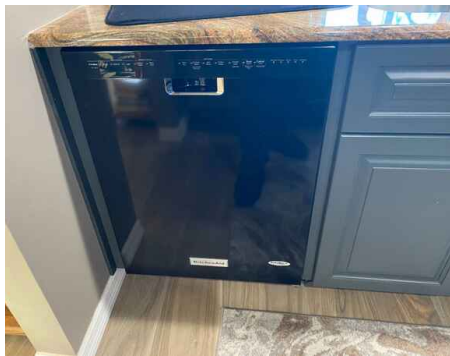
Dishwasher: Inspected Dishwasher

I inspected the dishwasher by turning it on and letting it run a short cycle.

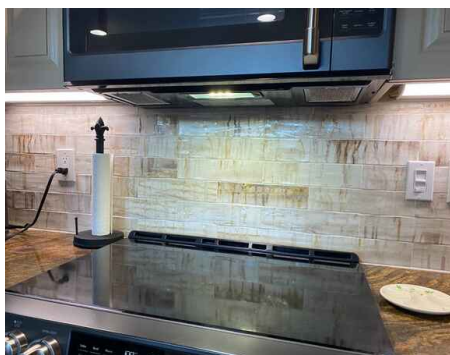
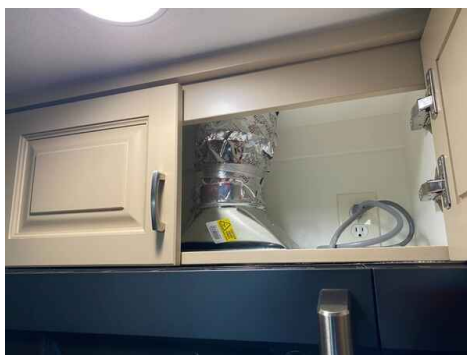
Exhaust Fan: Inspected Exhaust Fan

I inspected the exhaust fan in the kitchen. All mechanical exhaust fans should terminate outside.

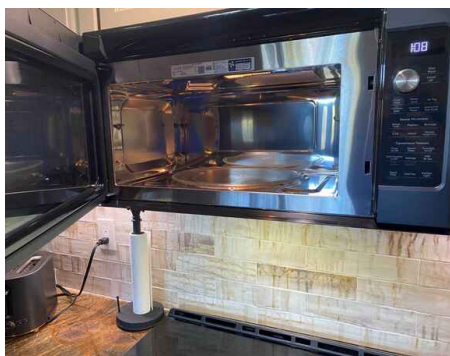
Built-in Microwave: Microwave Turned On

I observed that the microwave turned on. I do nothing more than that. Microwaves are beyond the scope of a home inspection.

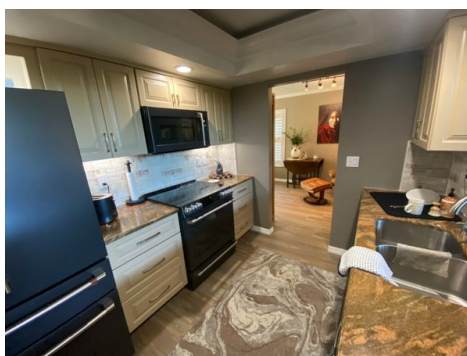
Countertops & Cabinets: Inspected Cabinets & Countertops

I inspected a representative number of cabinets and countertop surfaces.

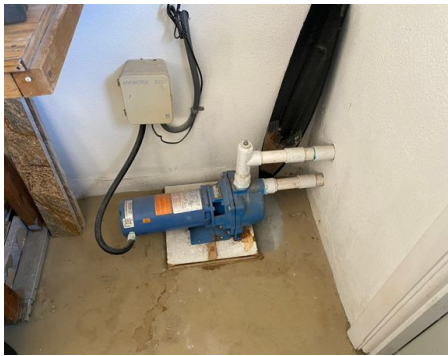
Well pump not tested: Well Pump

The well pump was not inspected as it is outside of the scope of a home inspection.
