APEX TEMPLATE FOR HOME INSPECTIONS

TABLE OF CONTENTS

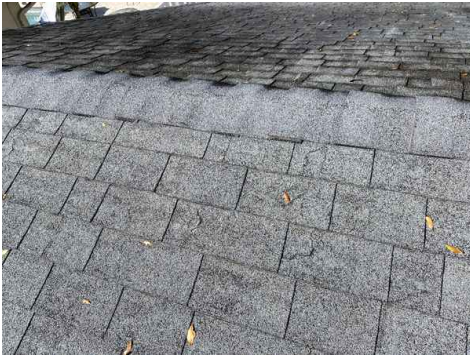
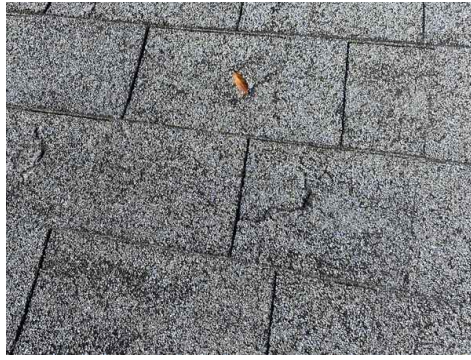
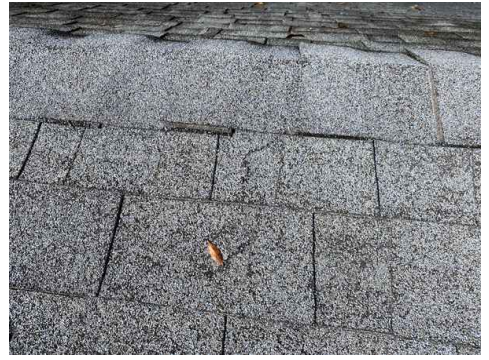
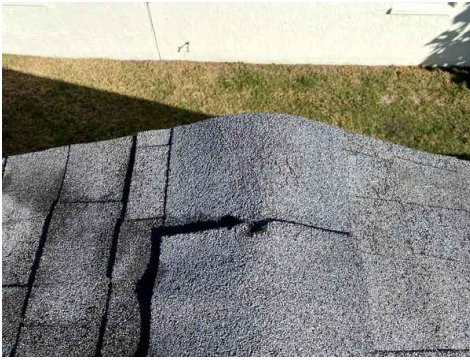
CRACKED ROOF-COVERING MATERIAL

I observed cracked and damaged shingles. Prone to leaking. Correction and further evaluation by a professional roofer is recommended.

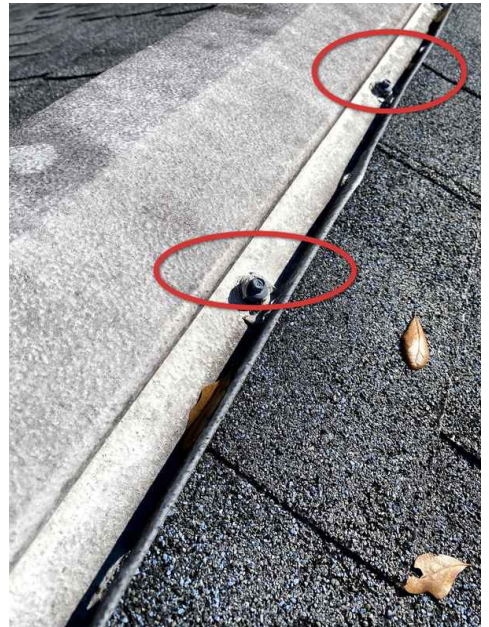
I observed indications of exposed fasteners at the roof-covering materials. Fasteners should not be exposed. Potential water entry points. Roof could leak. Further evaluation and correction is recommended.

Contact a qualified roofing professional.

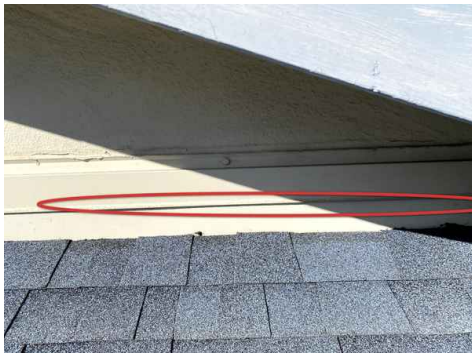
Loses flashing

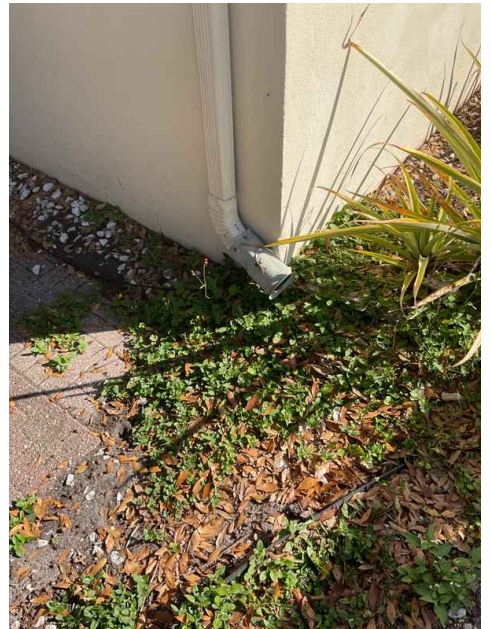
One or more downspouts drain too close to the home's foundation. This can result in excessive moisture in the soil at the foundation, which can lead to foundation/structural movement. Recommend a qualified contractor adjust downspout extensions to drain at least 6 feet from the foundation.

Contact a qualified roofing professional.

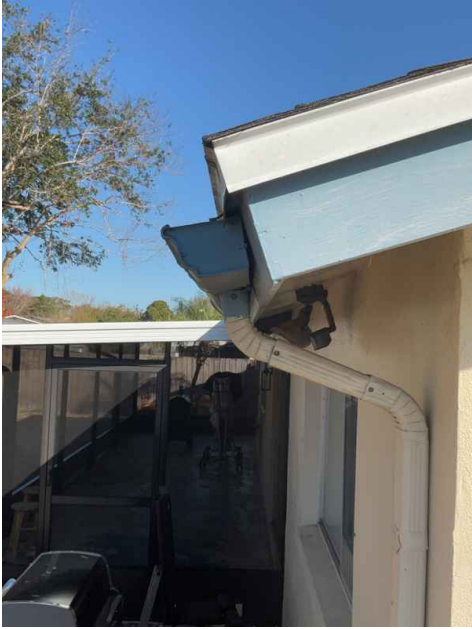
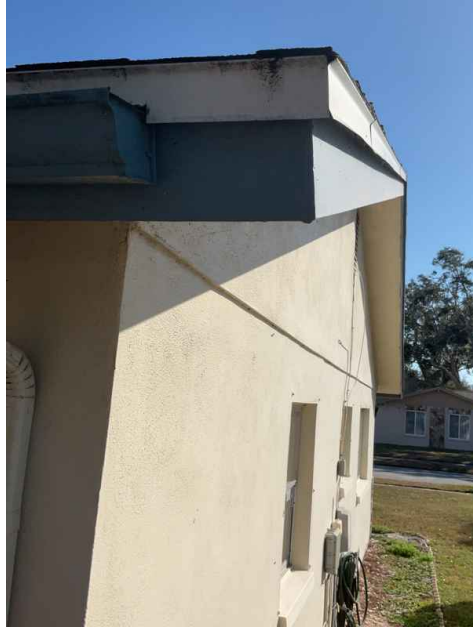
2.3.3 Roof Drainage Systems

GUTTER APPEARS UNDER SIZED AND RUNS SHORT OF HOUSE

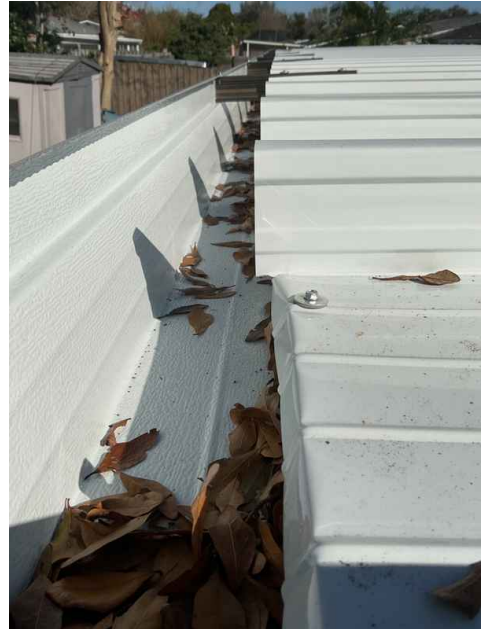
2.5.1 Gutters & Downspouts

DEBRIS IN GUTTERS

I observed debris in the gutter. Cleaning and maintenance is recommended.

Contact a qualified gutter contractor

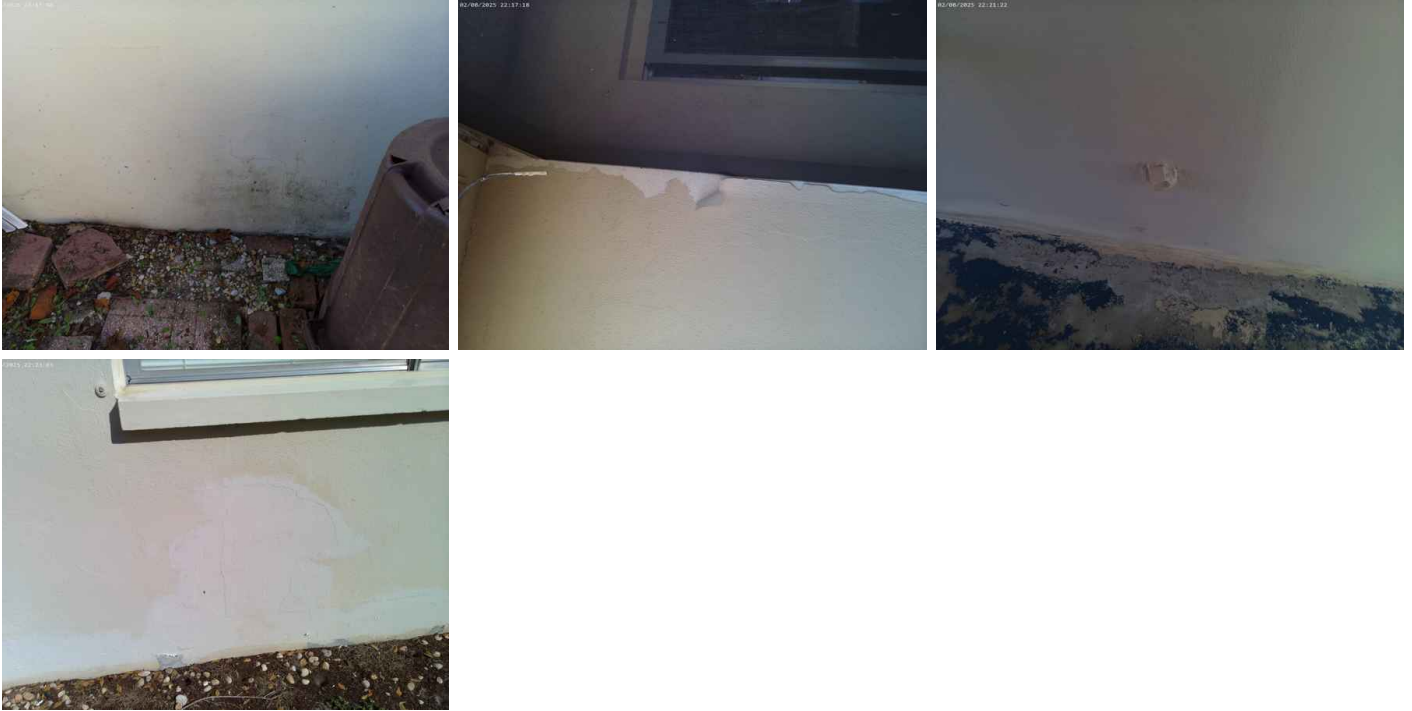
Wall-Covering, Flashing & Trim: Worn Out Areas of Exterior Wall-Covering

I observed indications of worn out areas, delayed maintenance, or aging.

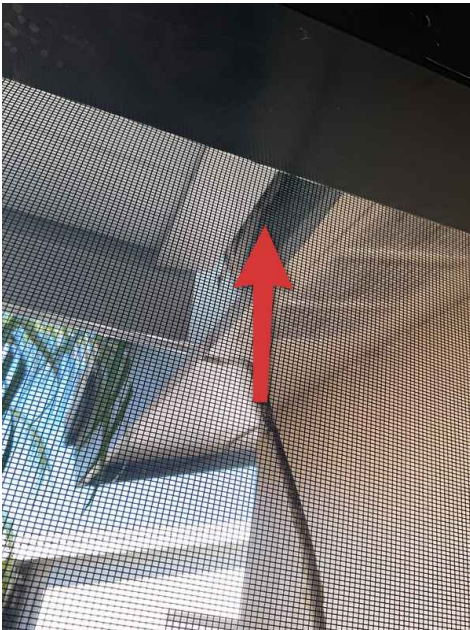
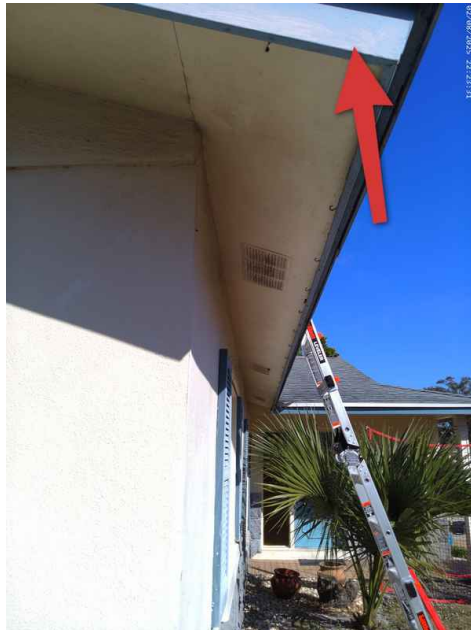
PAINT SURFACE IN POOR CONDITION

I observed indications of paint or staining in poor condition. Flaking, cracking, and worn areas. Correction and further evaluation is recommended.

No paint on eaves was patio was replaced.

Contact a qualified painting contractor.

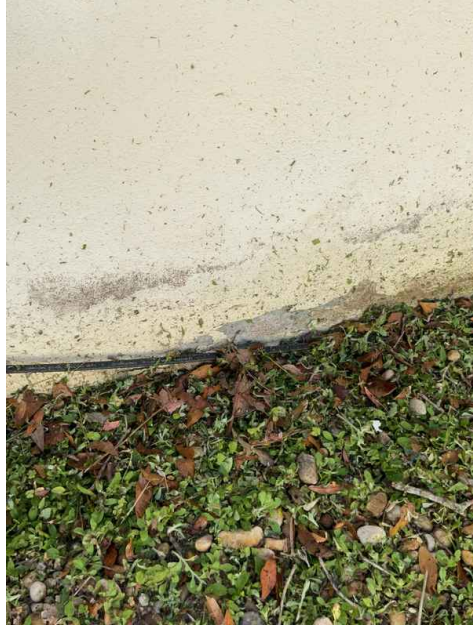
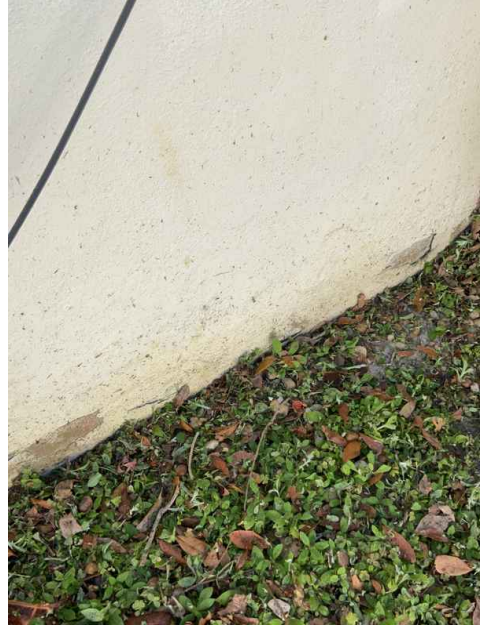
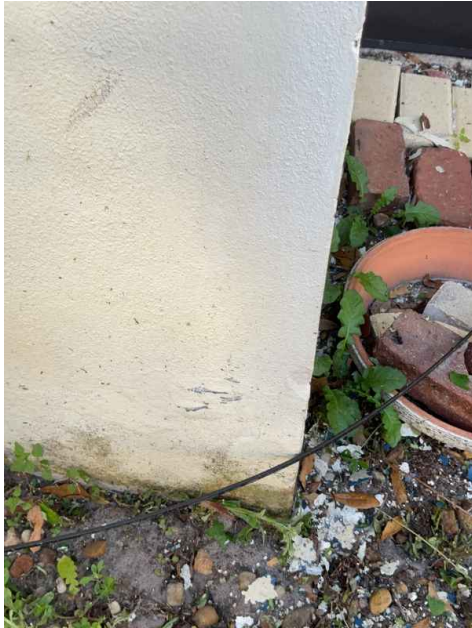
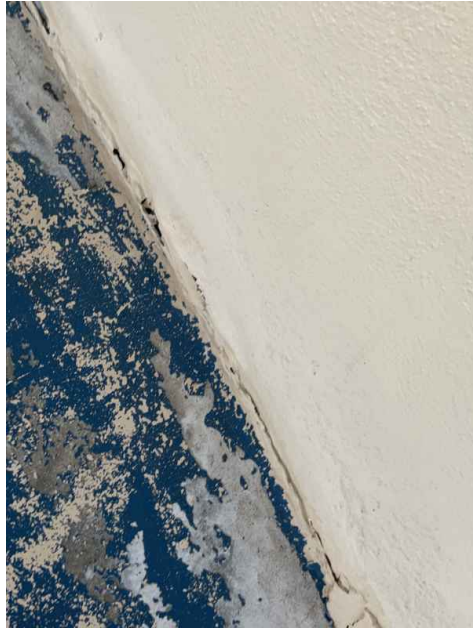
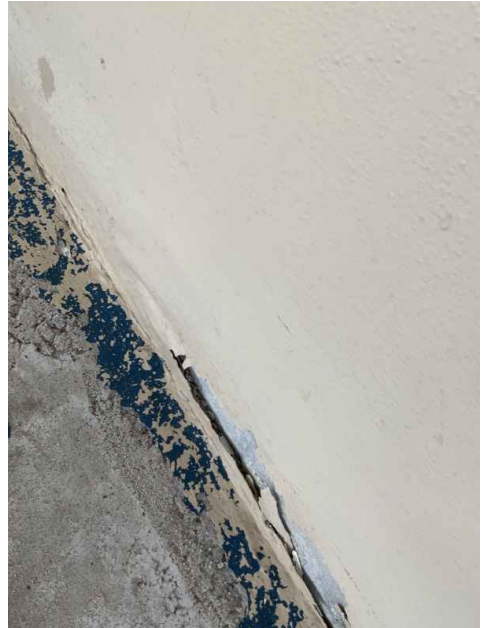
DAMAGED WALL-COVERING MATERIAL

I observed indications of a defect at the exterior wall-covering material.

Correction and further evaluation is recommended.

Contact a qualified professional.

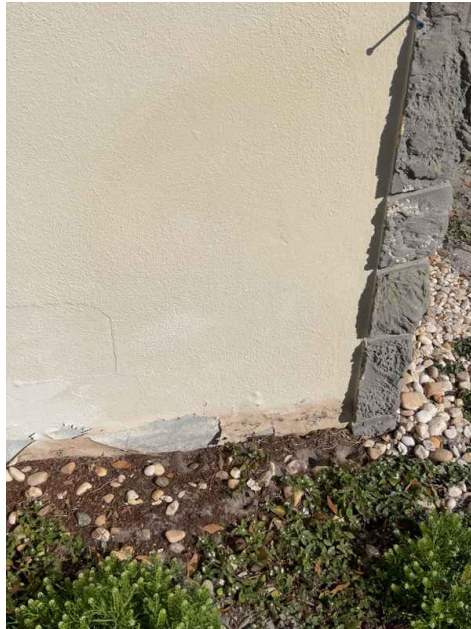
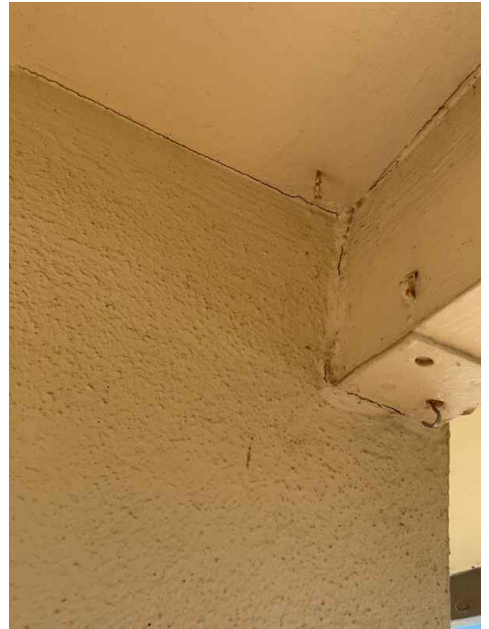
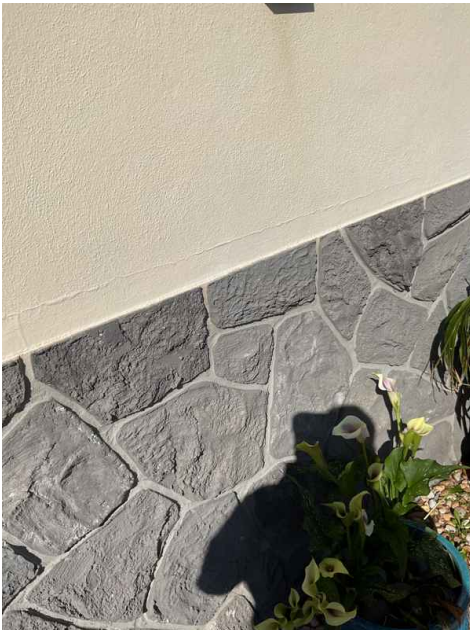
3.3.2 Wall-Covering, Flashing & Trim

CRACKING - MINOR

There are numerous cracks in the stucco some are from settling and if not repaired can lead to water infiltration.

Recommended DIY Project

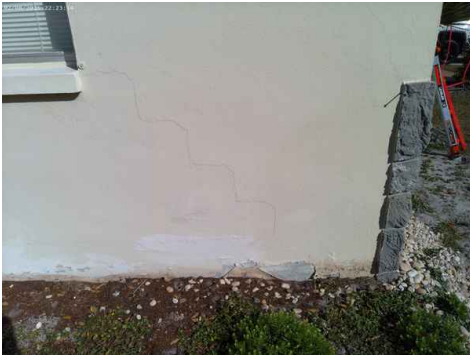
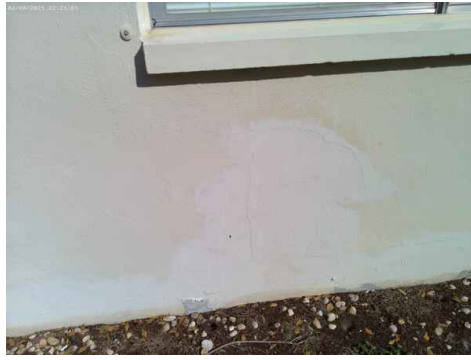
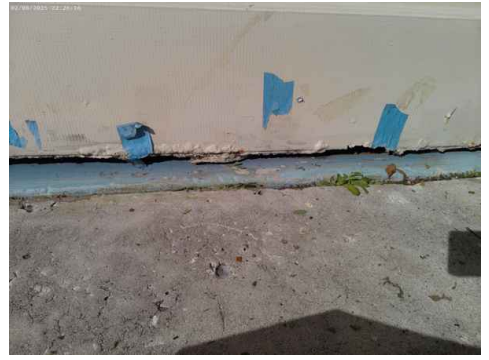
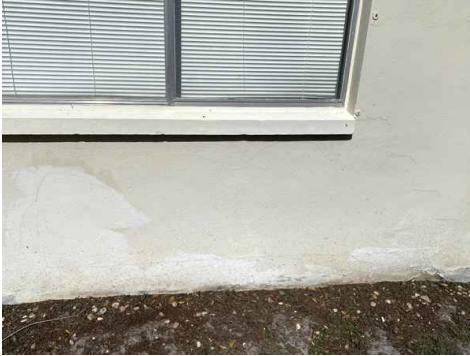
3.5.1 GFCIs & Electrical

MISSING GFCI

I observed indications that a GFCI is missing in an area that is required to keep people safe. none of the exterior outlets are up to current safety standards. Suggest replacing these outlets with GFCI outlets.

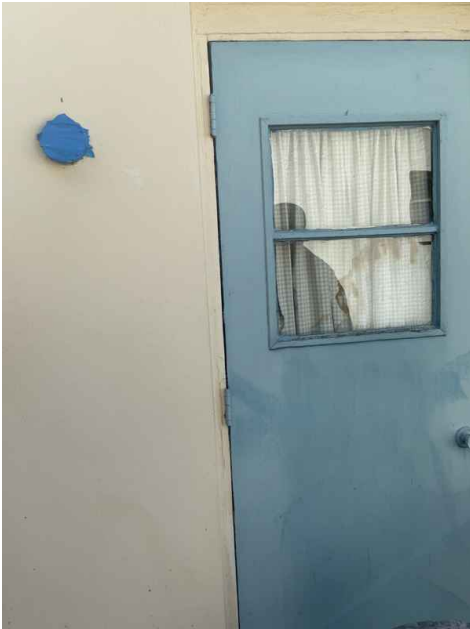
ELECTRICAL DEFECT

I observed indications of an electrical defect at the exterior. Missing exterior light from outside the door to the garage. The electrical box was covered by blue painter's tap which is not waterproof. Should be fixed or have a waterproof plate installed.

Contact a qualified electrical contractor.

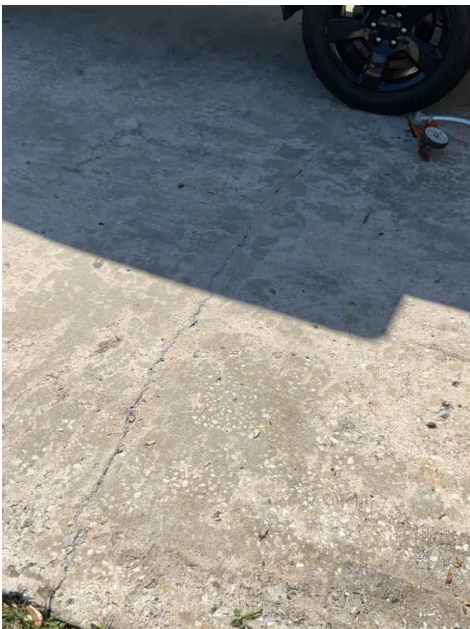
3.6.1 Walkways & Driveways

MINOR CRACKING AT DRIVEWAY

I observed indications of minor cracking and the upper layer of concrete has eroded exposing the aggregate in most areas.

Correction and further evaluation is recommended.

Contact a qualified concrete contractor.

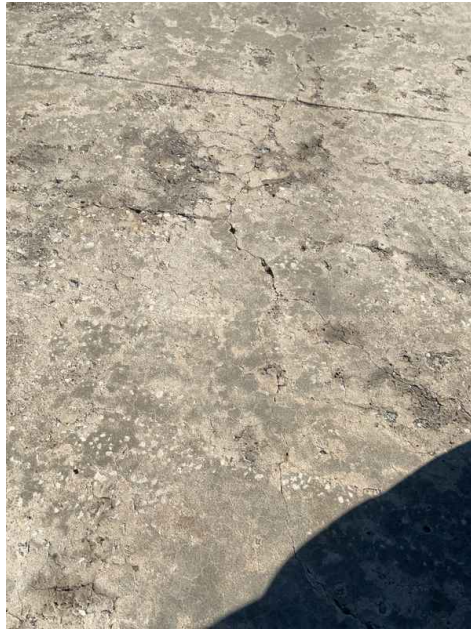
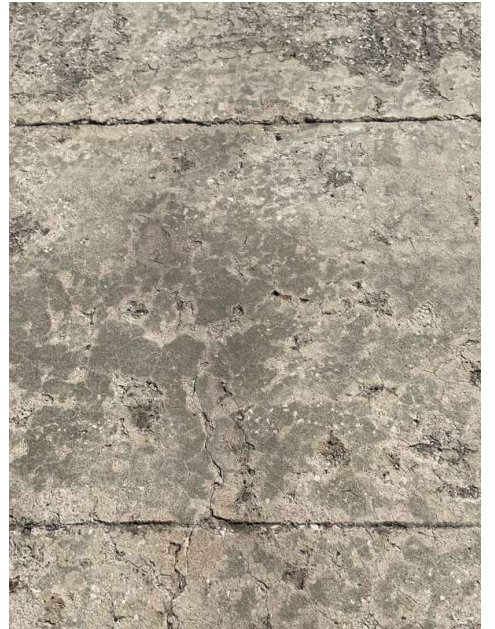
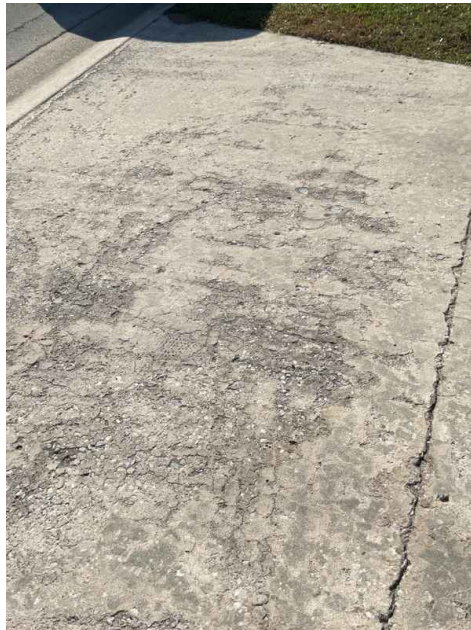
3.7.1 Porches, Patios, Decks, Balconies & Carports

WORN OUT SURFACES

I observed indications of worn out surfaces at the deck.

Recommended DIY Project

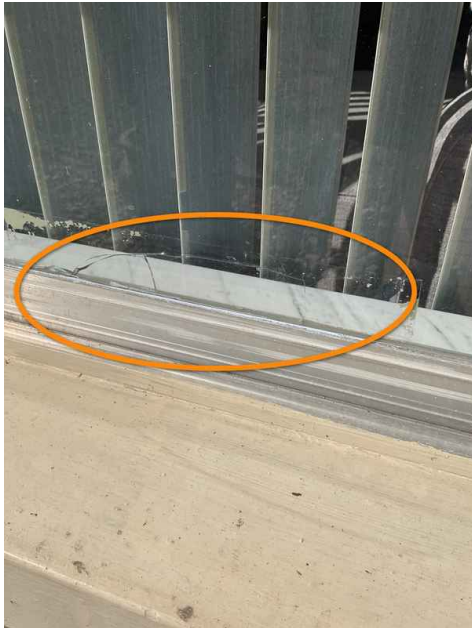
CRACKED WINDOWPANE

I observed a cracked glass windowpane.

Correction and further evaluation is recommended.

Contact a qualified window repair/installation contractor.

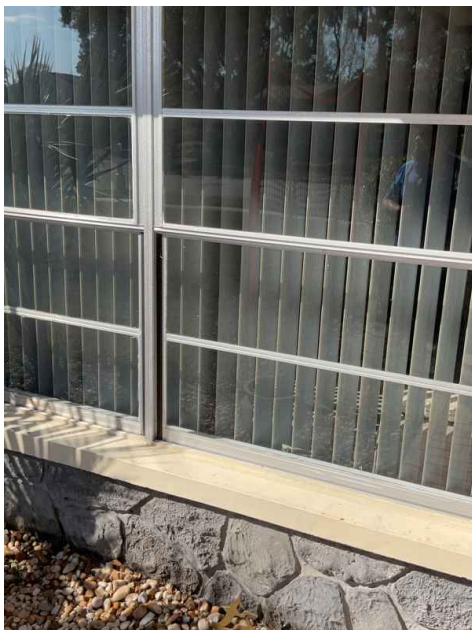
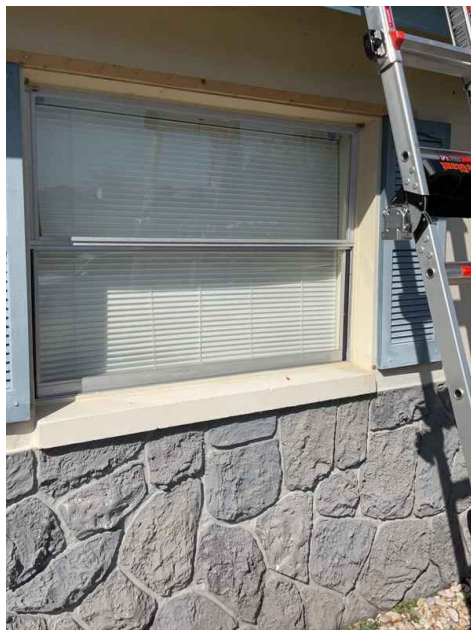
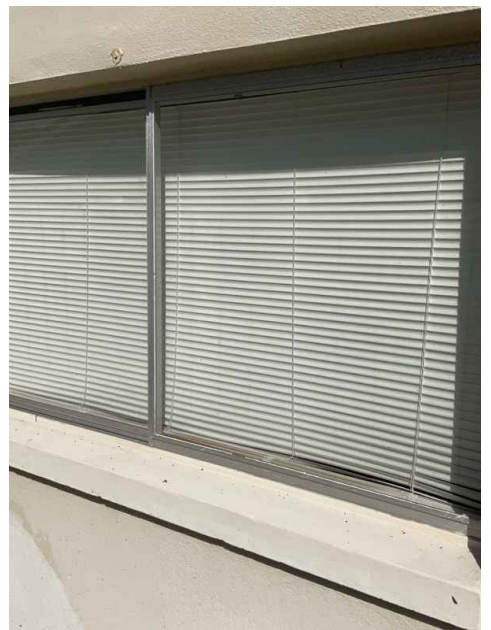
3.8.2 Windows

MISSING WINDOW SCREEN

I observed a missing window screen on all of the windows on the home.

Correction and further evaluation is recommended.

Contact a qualified handyman.

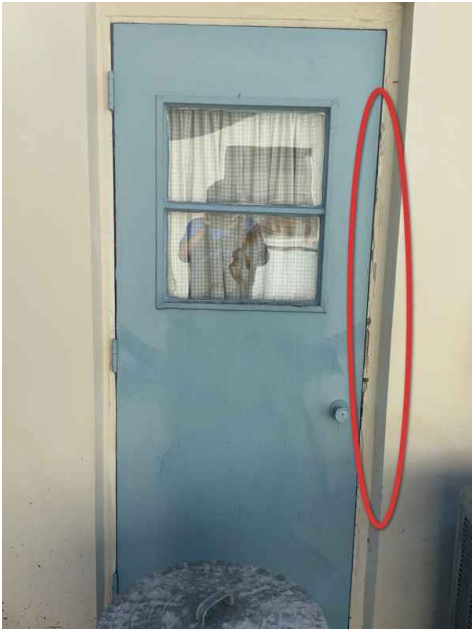
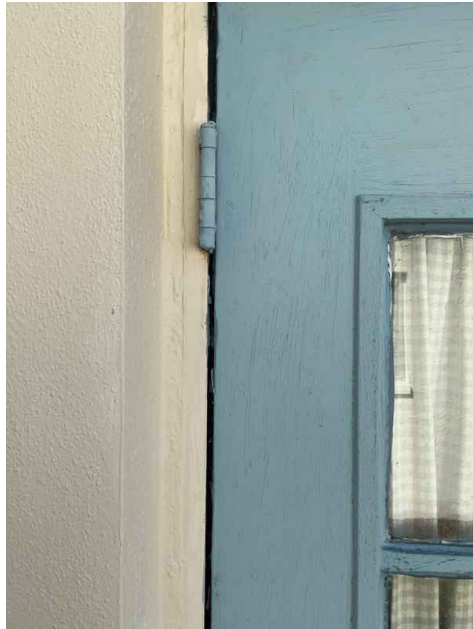
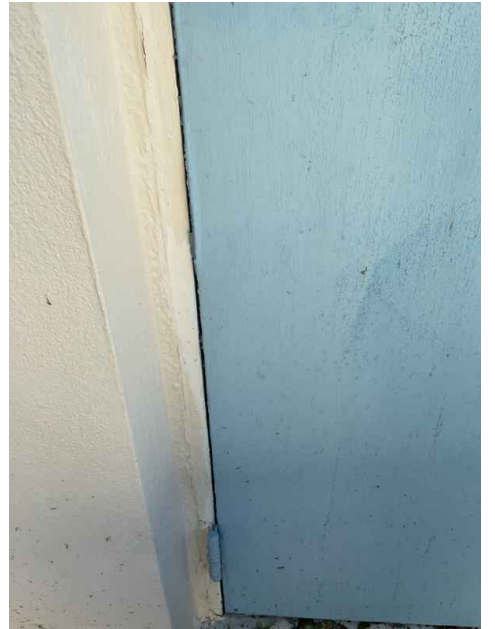
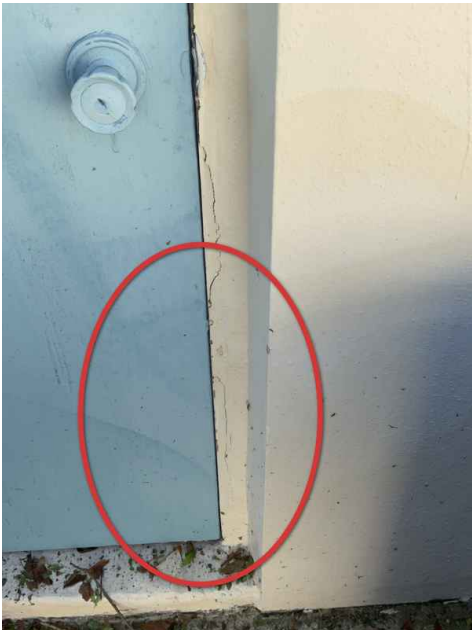
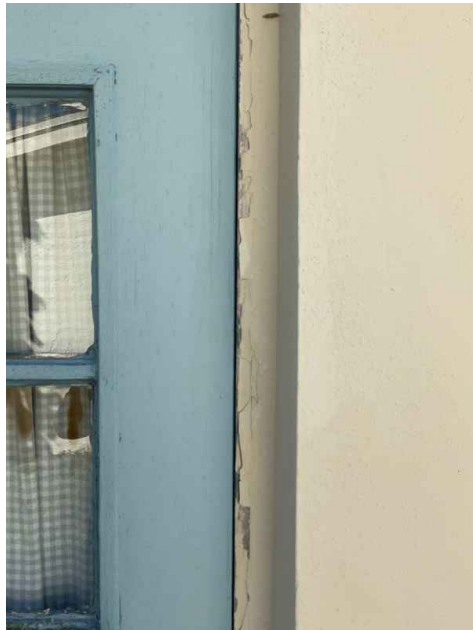
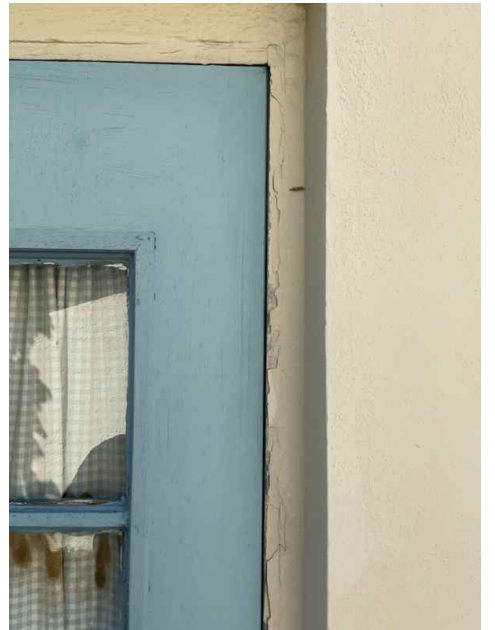
3.9.1 Exterior Doors

WOOD ROT AT DOOR

I observed wood rot at the exterior door to the garage. The door had damage in numerous areas that need to be addressed on both the door and the door jamb.

Correction and further evaluation is recommended.

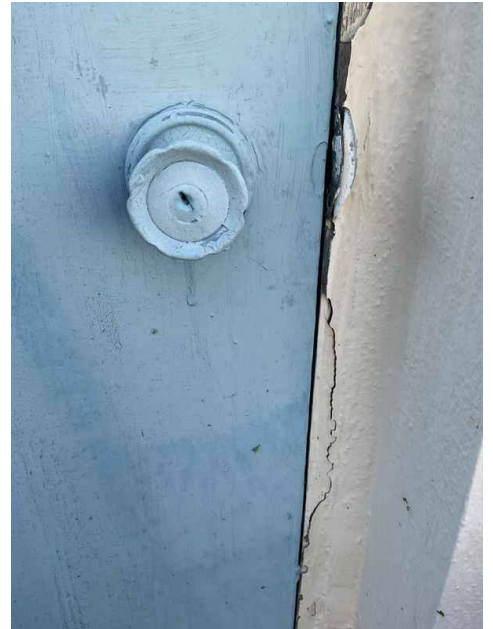
3.9.2 Exterior Doors

DOOR HARDWARE DAMAGED

I observed damage at the exterior door hardware, the doorknob has been painted over and the keyhole is unusable. Correction and further evaluation is recommended.

Recommended DIY Project

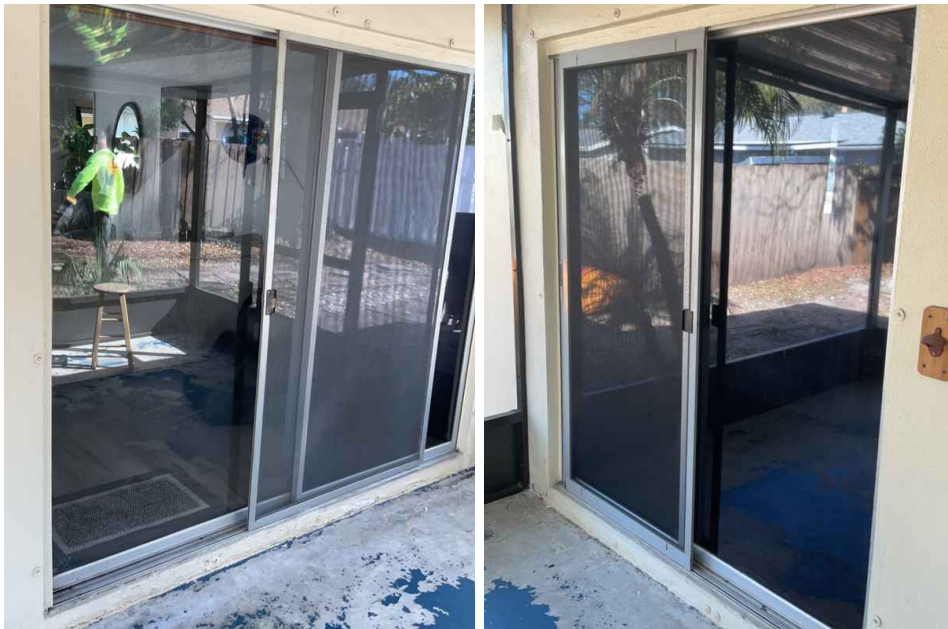
3.9.3 Exterior Doors

SLIDER DOOR DEFECT

I observed indications of a defect at the slider door. Hard to open both sliders rear of residence. Correction and further evaluation is recommended.

Contact a qualified door repair/installation contractor.

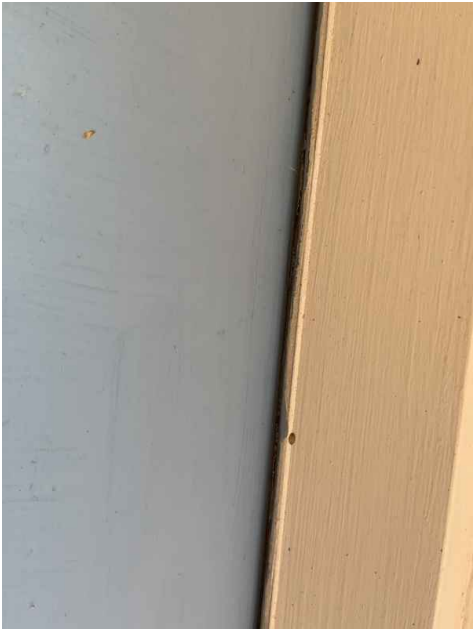
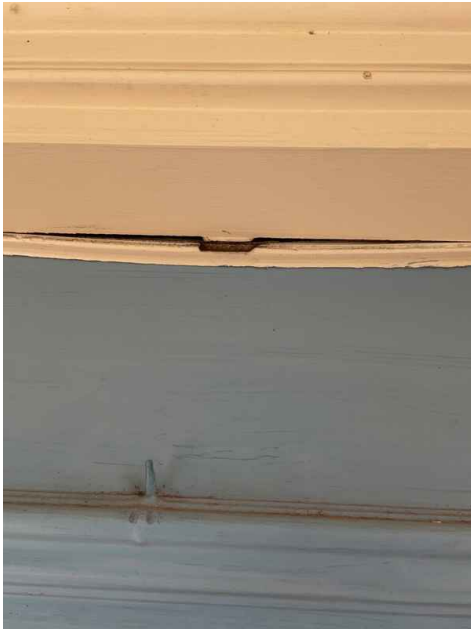
3.9.4 Exterior Doors

WEATHER SEAL DAMAGE

the weather seal around the front door has damage, which can lead to water intrusion or energy loss.

Recommended DIY Project

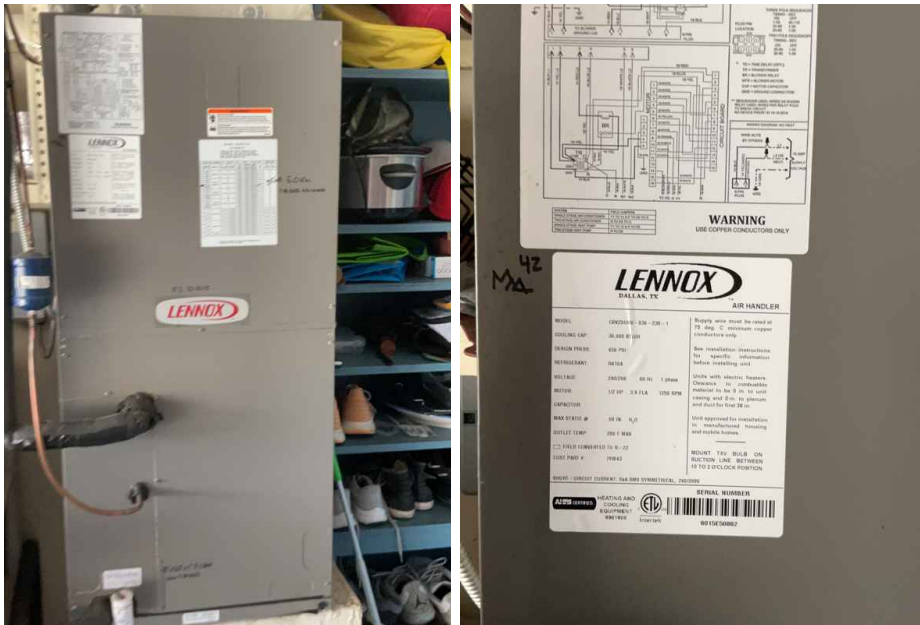
Heating System Information: Energy Source

Electric, Heat Pump

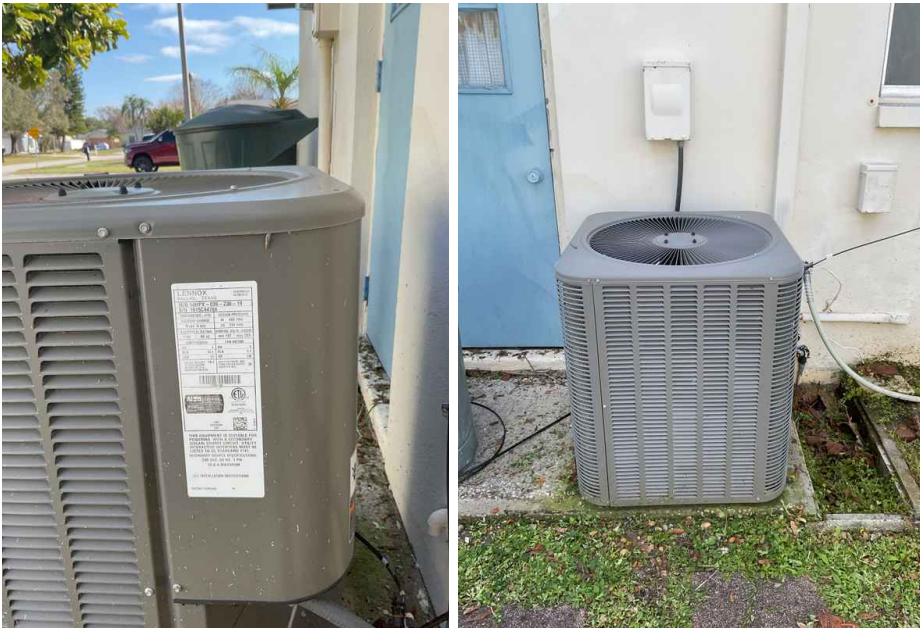
Cooling System Information: Service Disconnect Inspected

I observed a service disconnect within sight of the cooling system.

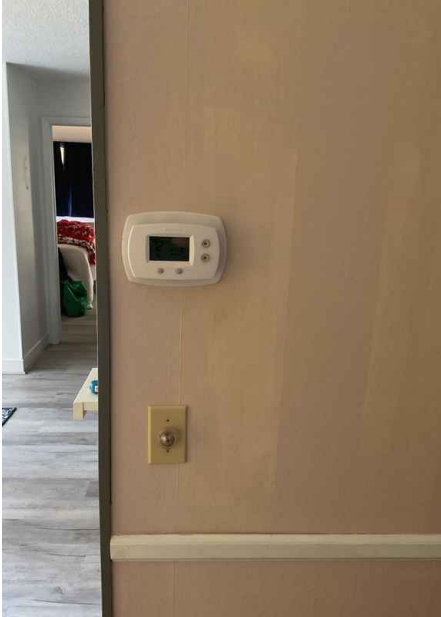
**Thermostat and Normal
Operating Controls: Thermostat
Location**

Dining room, First floor

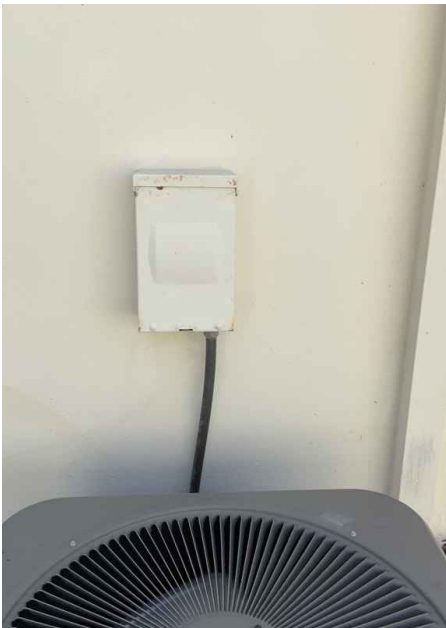
Thermostat and Normal Operating Controls: Emergency Shut-Off Switch Inspected

I observed an emergency shut-off switch. I inspected it. It worked when I used it during my inspection.

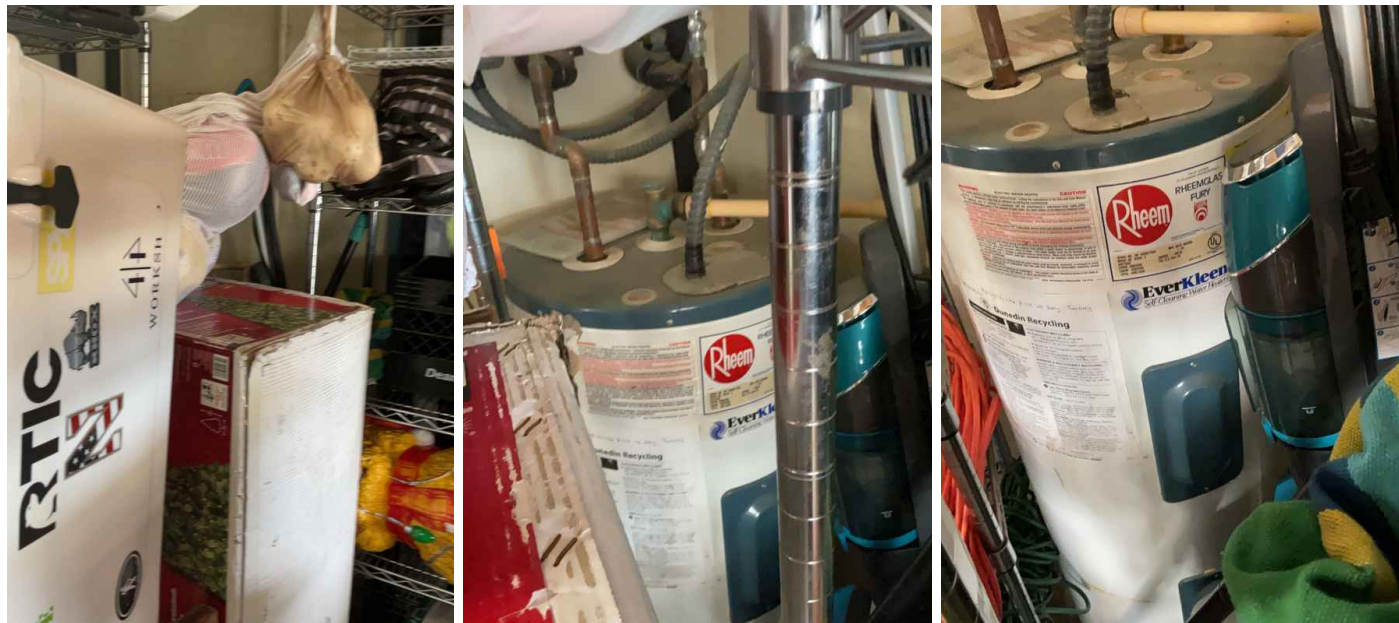
Hot Water Source: Inspected Hot Water Source

I inspected the hot water source and equipment according to the [Home Inspection Standards of Practice](#).

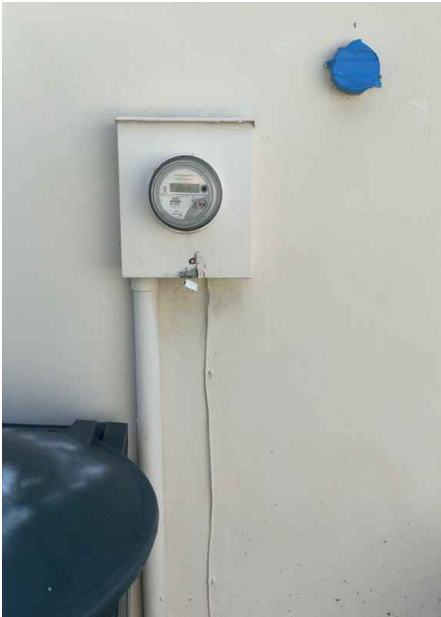
Electric Meter & Base: Inspected the Electric Meter & Base

I inspected the electrical electric meter and base.

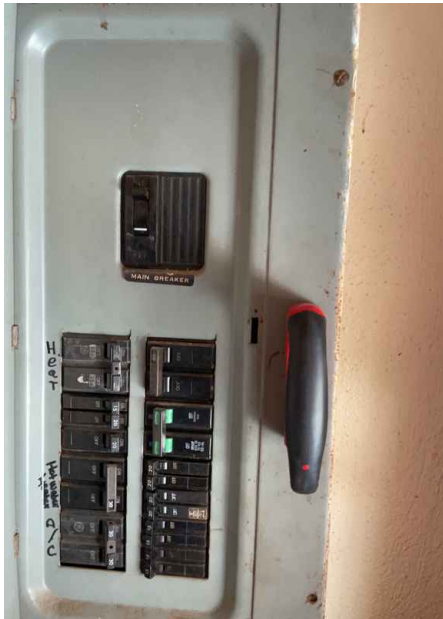
**Main Service Disconnect:
Inspected Main Service
Disconnect**

I inspected the electrical main service disconnect.

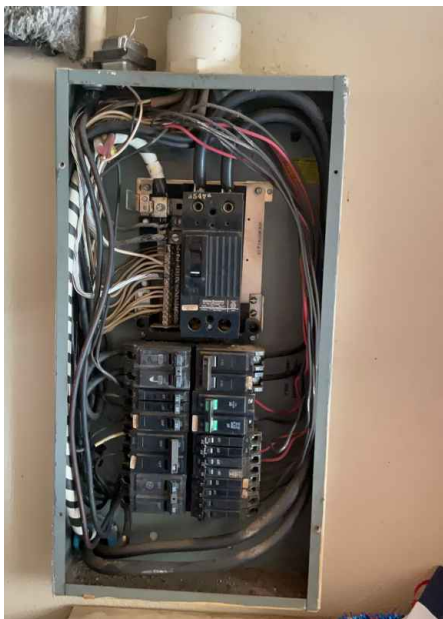
**Electrical Wiring: Type of Wiring,
If Visible**

NM-B (Romex)

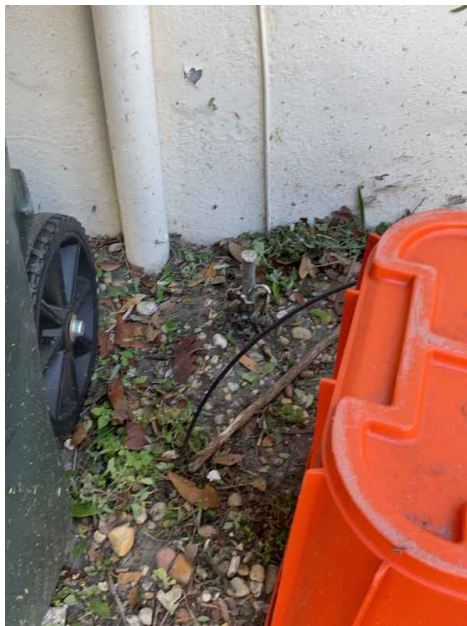
Service Grounding & Bonding: Inspected the Service Grounding & Bonding

I inspected the electrical service grounding and bonding.

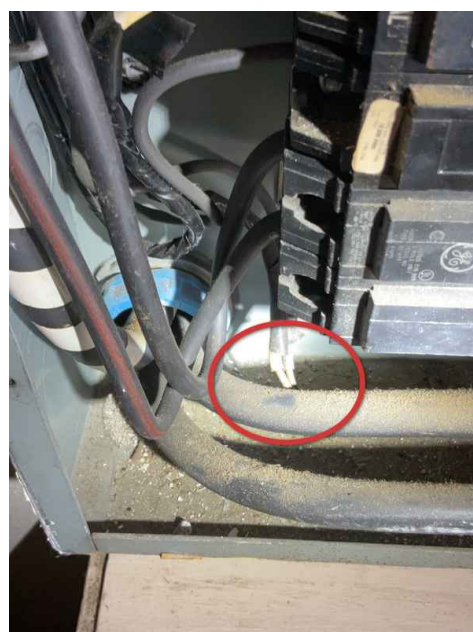
IMPROPER WIRING

I observed indications of improper wiring. Electrical hazard. There were two wires that did not have a wire nut connecting them. They did not test as live but should still have a wire nit or be removed.

Contact a qualified electrical contractor.

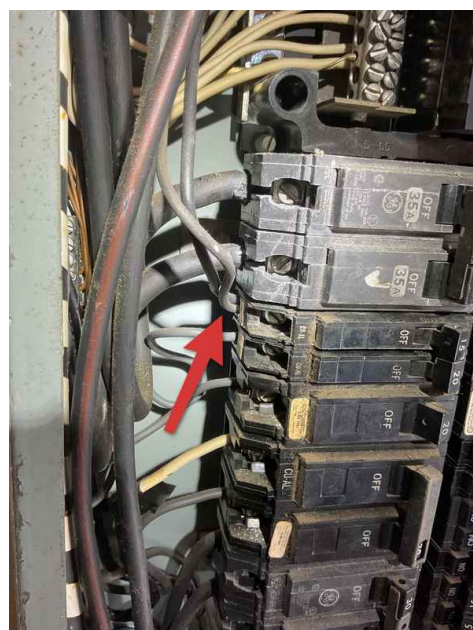
7.5.1 Panelboards & Breakers

I observed doubled hot conductor wires connected to the same single breaker disconnect.

Contact a qualified electrical contractor.

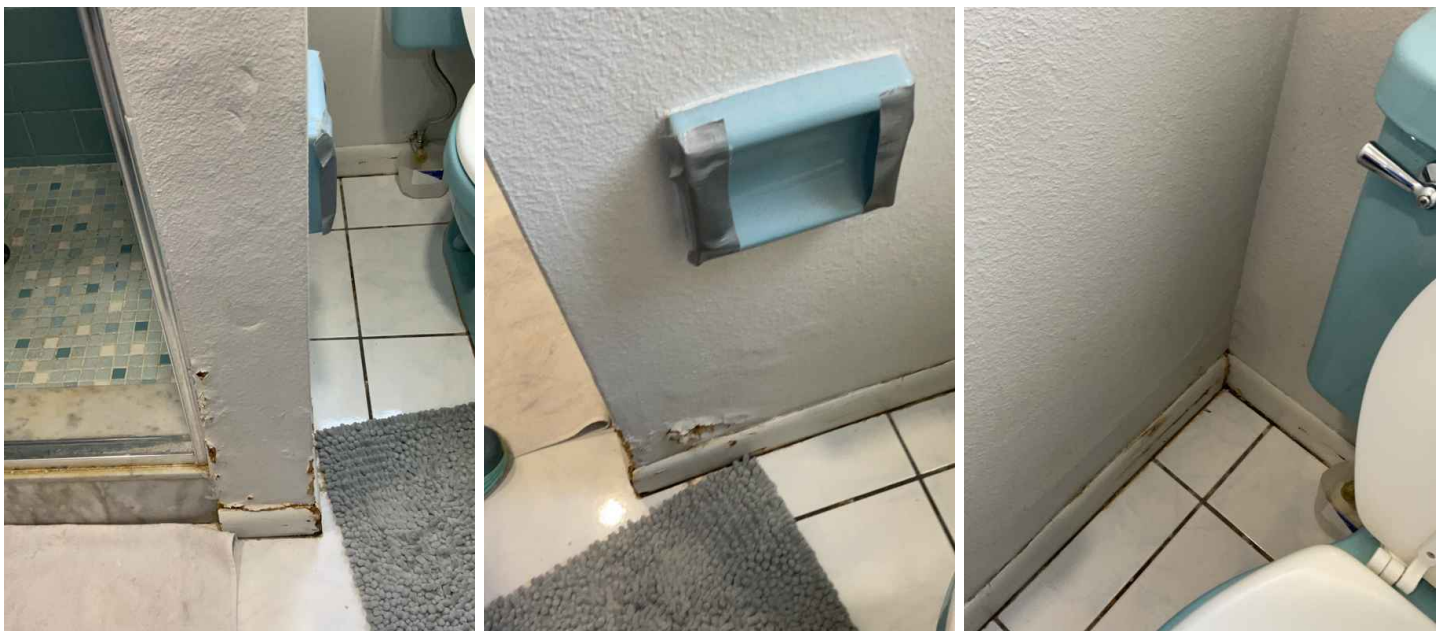
ACTIVE WATER LEAK

I observed indications of an active water leak. Water has leaked and caused damage to the wall and it tested high moisture 1/4 way up the entire side wall of the shower in the mater bath

Contact a qualified plumbing contractor.

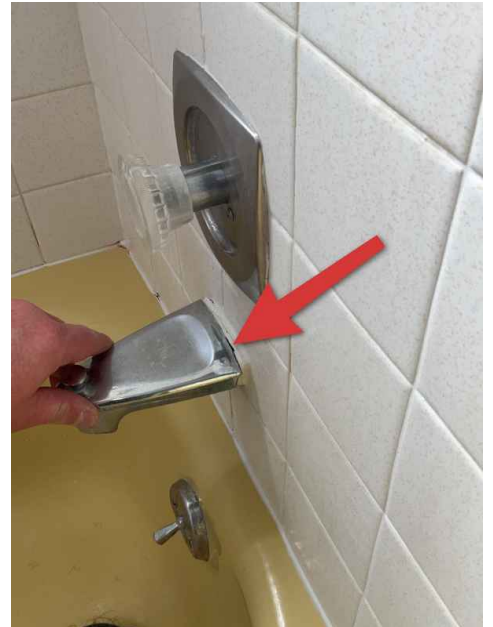
Hallway bath

LOOSE FIXTURE

HALL BATH LOOSE

I observed indications that the fixture is loose. Not secure. Not installed properly. Loose.

Contact a qualified plumbing contractor.

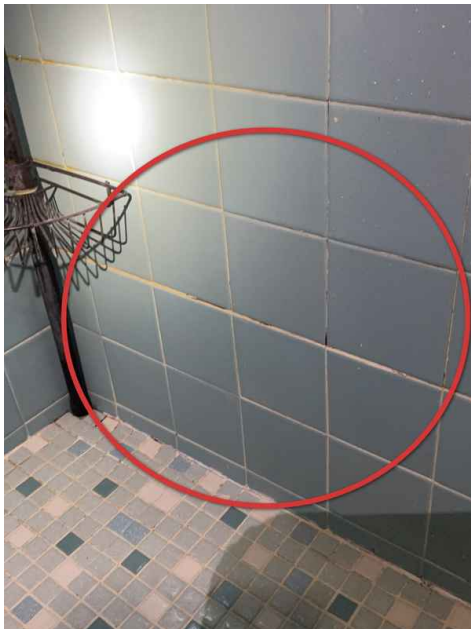
„ Master

DAMAGED TILES IN SHOWER

I observed damaged tiles in the bathroom shower.

Contact a qualified general contractor.

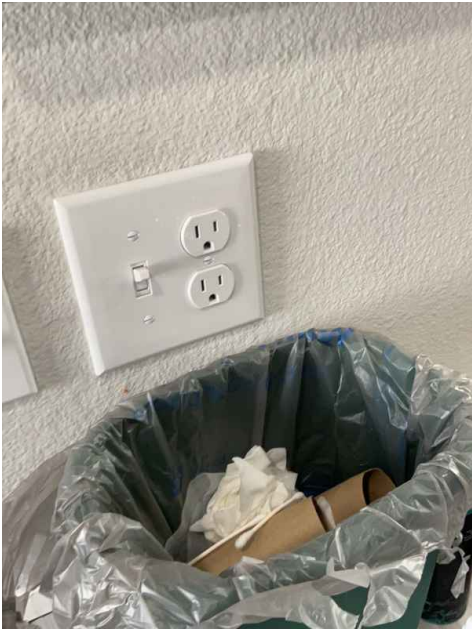
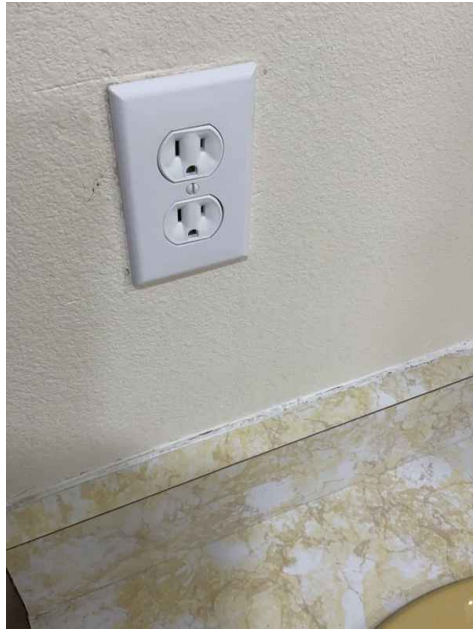
I observed that the receptacle in the bathroom is not testing as being GFCI protected. This is a hazardous condition.

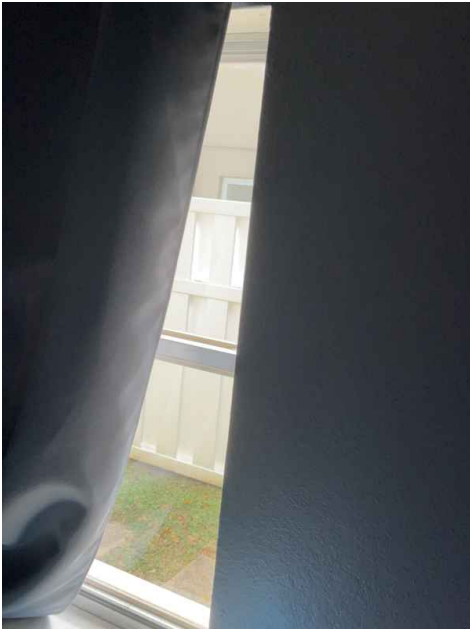
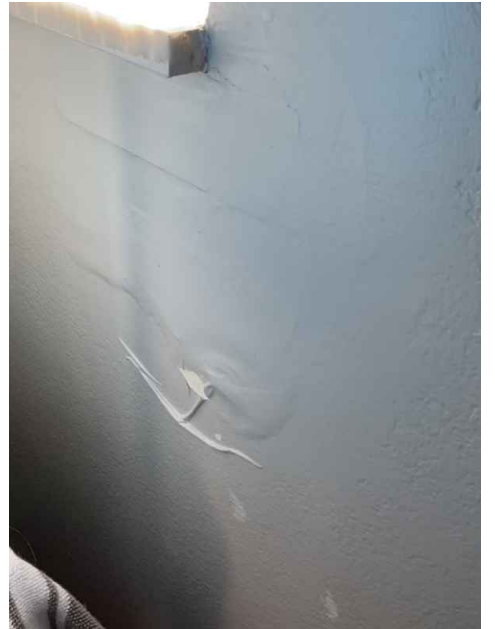
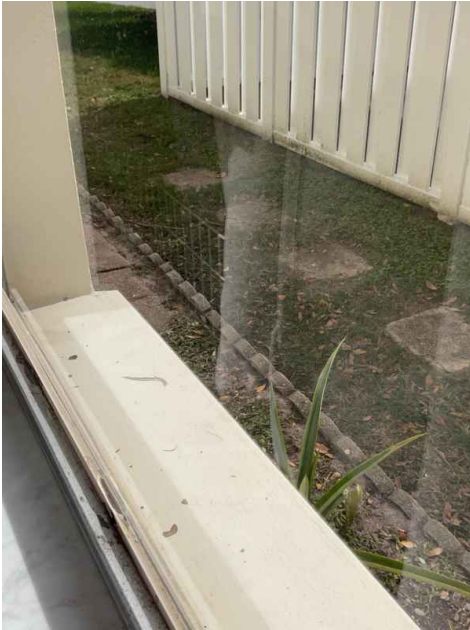
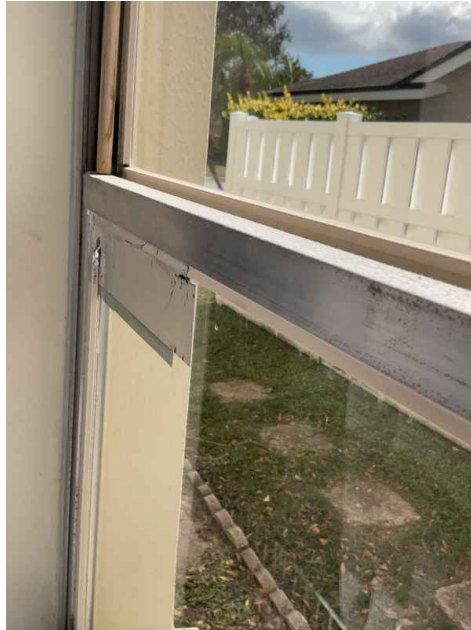
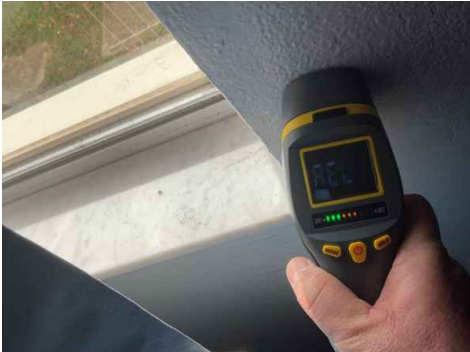
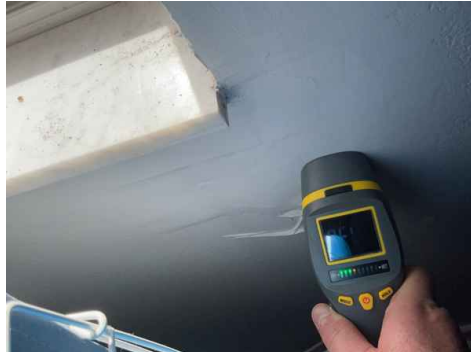
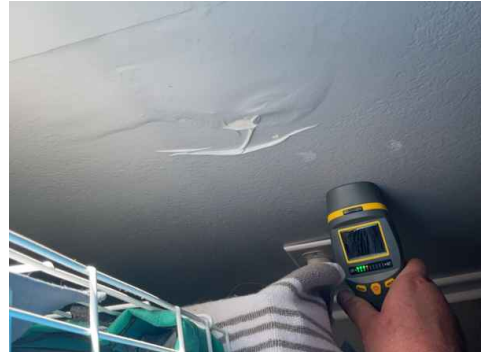
MOISTURE AT WINDOW

I observed indications of excessive moisture or water intrusion at a window. Further evaluation is recommended.

Contact a qualified window repair/installation contractor.
