APEX TEMPLATE FOR HOME INSPECTIONS

TABLE OF CONTENTS

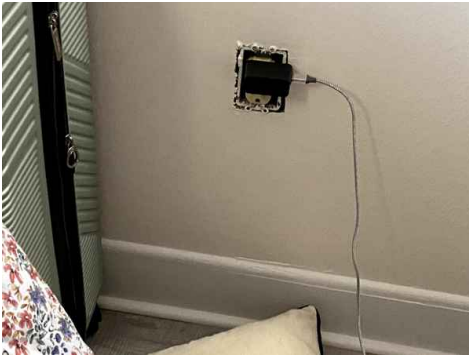
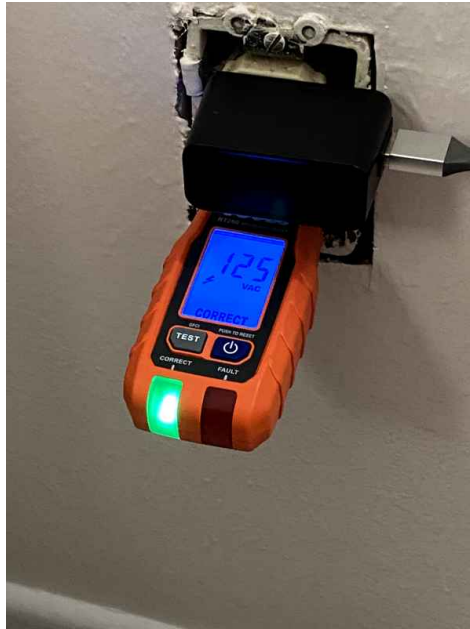
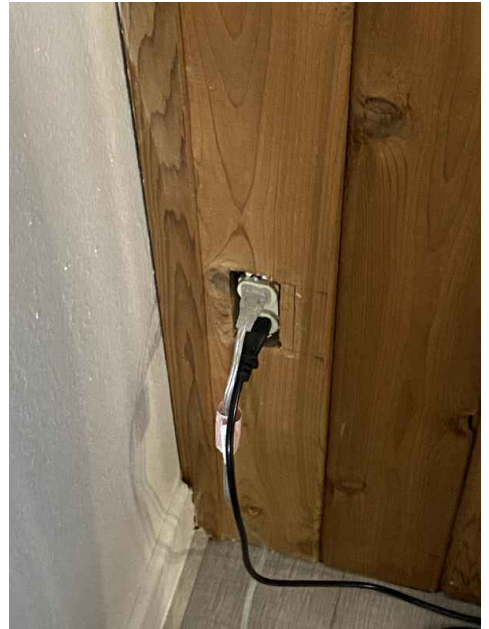
10.3.1 Switches, Fixtures & Receptacles

COVER PLATES MISSING OR DAMAGED

I observed one or more wall receptacles with a missing or damaged cover plate.

Contact a qualified electrical contractor.

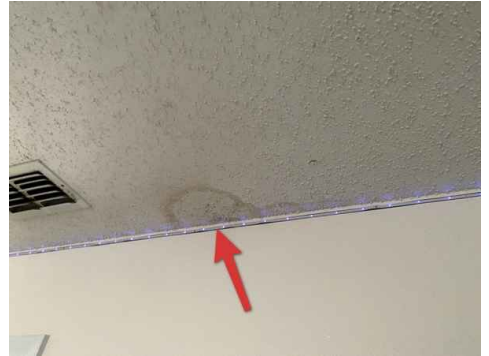
10.4.1 Floors, Walls, Ceilings

MOISTURE DAMAGE

Stains on the ceiling visible at the time of the inspection appeared to be the result of moisture intrusion. The source of moisture may have been corrected. Recommend further examination by a qualified contractor to provide confirmation. This spot tested negative for moisture on a moisture meter.

Contact a qualified professional.

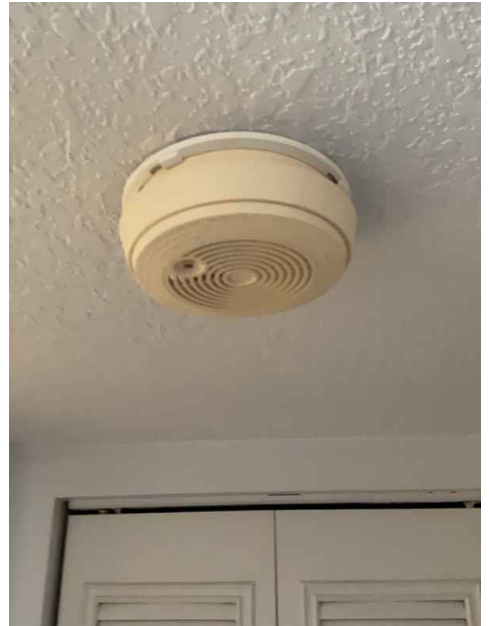
10.5.1 Presence of Smoke and CO Detectors

OLD DETECTORS, NEW DETECTORS RECOMMENDED

I observed indications of old smoke detectors in the house. Detectors should be replaced every 5-10 years. They should be hard-wired with electricity and have a battery backup feature in case the electricity turns off. New smoke detectors are recommended.

Contact a qualified professional.

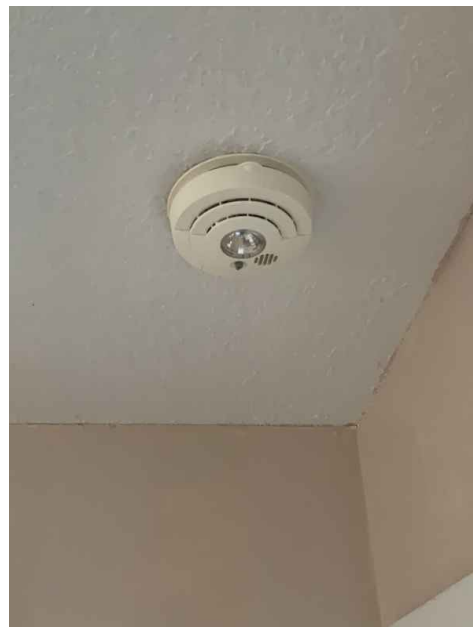
I observed indications of a major defect during the inspection. Major defect Smoke detector by garage door is not working when tested. Correction and further evaluation is recommended.

Contact a qualified electrical contractor.

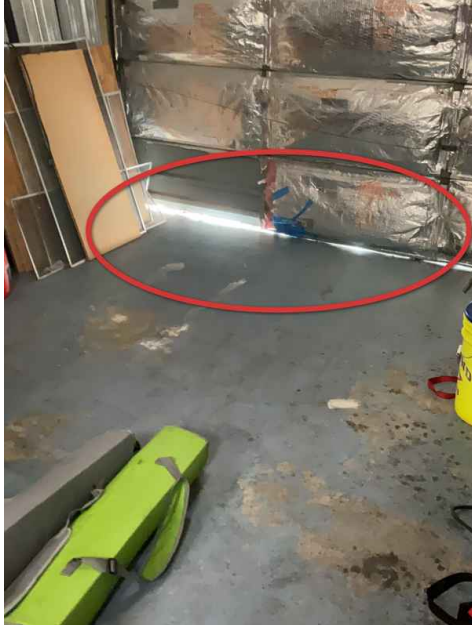
WEATHER STRIPPING AT GARAGE DOOR IN POOR CONDITION

I observed indications that the weather stripping at the garage door is in poor condition.

Contact a qualified garage door contractor.

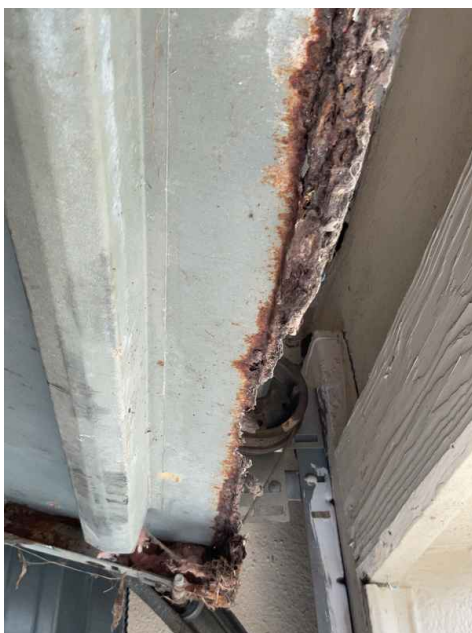
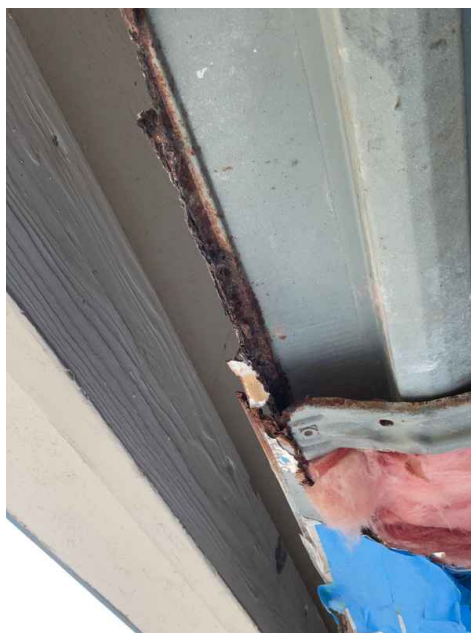
12.2.2 Garage Vehicle Door

DAMAGE TO GARAGE DOOR

I observed indications of damage to the garage door itself.

Contact a qualified garage door contractor.

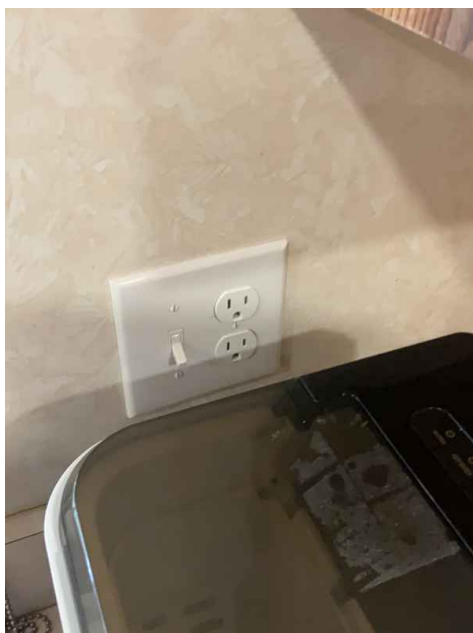
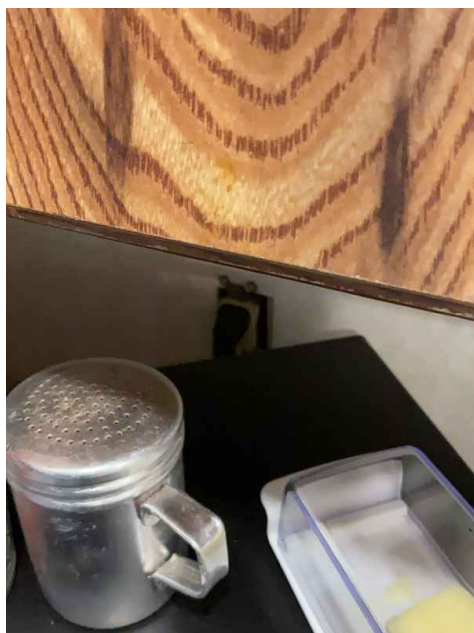
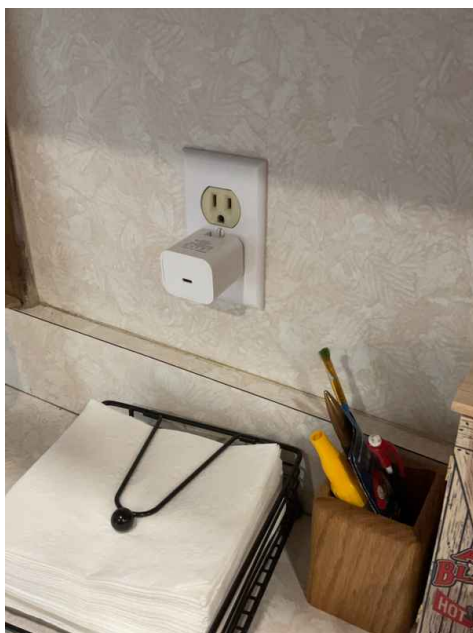
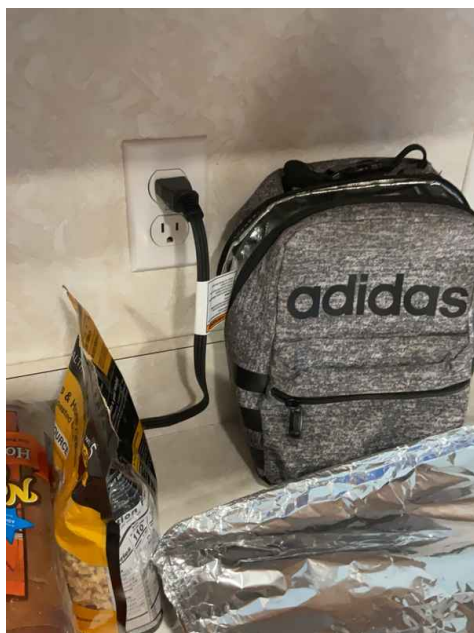
MISSING GFCI PROTECTION

Major Defect

I observed indications of missing GFCI protection in the kitchen. All kitchen counter receptacles are required to be GFCI-protected. Not up to current safety standards.

Contact a qualified electrical contractor.
